Access Compliance Report

Public Rights-of-Way

(Island Curb Cuts)

Intersection ID: 51519	Main Street: E_JOHN_BELK_RA	Cross Street: SOUTH_BV	Location:	W
ADA ID: D7FBEEA18ED7	Curb Cut Type: MedianRefuge2	Initial Pass/Fail: Pass	Overall Compliance: No	Severity Score: 10.25
Codes/Mitigation Info/Possible Solution		Field Measurements/Component Compliance

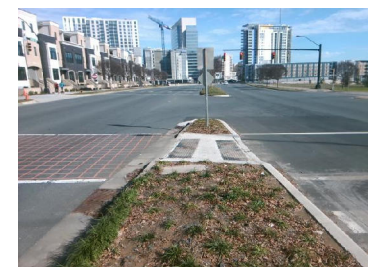
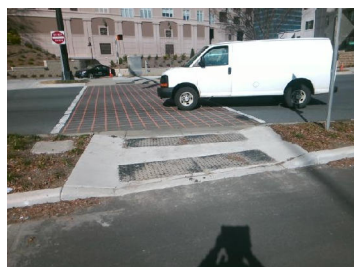
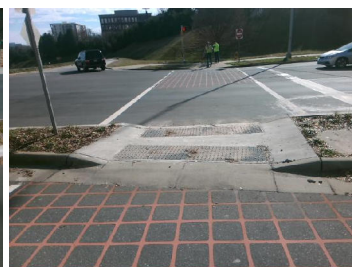
Compliance	Description	Data	Compliance	Description	Data
Yes	Refuge 1 Length (In)	40.0	Yes	Gutter 1 Ponding?	No
Yes	Refuge 1 Width (In)	100.0	Yes	Gutter 1 Lip Ht (In)	0.0
Yes	Refuge 1 Slope (%)	0.6	Yes	Gutter 1 Slope (%)	0.4
Yes	Refuge 1 X Slope (%)	1.6	Yes	Gutter 1 X Slope (%)	1.3
N/A	Painted X Walk1?	Yes	Yes	DWS 1 Provided?	Yes
N/A	X Walk 1 Direction	To NW	Yes	DWS 1 Contrast?	Yes
N/A	X Walk 1 Width (In)	188.0	Yes	DWS 1 Length (In)	24.0
N/A	Road 1 Slope (%)	1.3	Yes	DWS 1 Full Width?	Yes
N/A	Road 1 X Slope (%)	3.0	No	DWS 1 Offset (In)	2.5
Yes	Refuge 2 Length (In)	40.0	Yes	Gutter 2 Ponding?	No
Yes	Refuge 2 Width (In)	100.0	Yes	Gutter 2 Lip Ht (In)	0.0
Yes	Refuge 2 Slope (%)	4.8	No	Gutter 2 Slope (%)	7.4
Yes	Refuge 2 X Slope (%)	0.3	Yes	Gutter 2 X Slope (%)	0.0
N/A	Painted X Walk2?	Yes	Yes	DWS 2 Provided?	Yes
N/A	X Walk 2 Direction	To SE	Yes	DWS 2 Contrast?	Yes
N/A	X Walk 2 Width (In)	182.0	Yes	DWS 2 Length (In)	24.0

N/A	Road 2 Slope (%)	1.8	Yes	DWS 2 Full Width?	Yes
N/A	Road 2 X Slope (%)	3.8	No	DWS 2 Offset (In)	4.0
N/A	Refuge 3 Length (in)	N/A	N/A	Gutter 3 Ponding?	N/A
N/A	Refuge 3 Width (in)	N/A	N/A	Gutter 3 Lip Ht (in)	N/A
N/A	Refuge 3 Slope (%)	N/A	N/A	Gutter 3 Slope (%)	N/A
N/A	Refuge 3 XSlope (%)	N/A	N/A	Gutter 3 XSlope (%)	N/A
N/A	Painted X Walk3?	N/A	N/A	DWS 3 Provided?	N/A
N/A	X Walk 3 Direction	N/A	N/A	DWS 3 Contrast?	N/A
N/A	X Walk 3 Width (in)	N/A	N/A	DWS 3 Length (in)	N/A
N/A	Road 3 Slope (%)	N/A	N/A	DWS 3 Full Width?	N/A
N/A	Road 3 XSlope (%)	N/A	N/A	DWS 3 Offset (in)	N/A
Yes	Any Obstructions?	N/A	N/A	Storm Grate/Utility Hazard?	No
N/A	Obstruction Type		N/A	Storm Grate/Utility Type	
		N/A			N/A
N/A	Surface Condition	Good

Remove & Replace Detectable Warning System. Remove & Replace Gutter.
