# Access Compliance Report

## Public Rights-of-Way

### (Island Curb Cuts)

Intersection ID: 53534	Main Street: N_JOSH_BIRMINGHAM_PY	Cross Street: WILKINSON_BV	Location:	S
ADA ID: D92D81599A99	Curb Cut Type: MedianRefuge2	Initial Pass/Fail: Pass	Overall Compliance: No	Severity Score: 0
Codes/Mitigation Info/Possible Solution		Field Measurements/Component Compliance

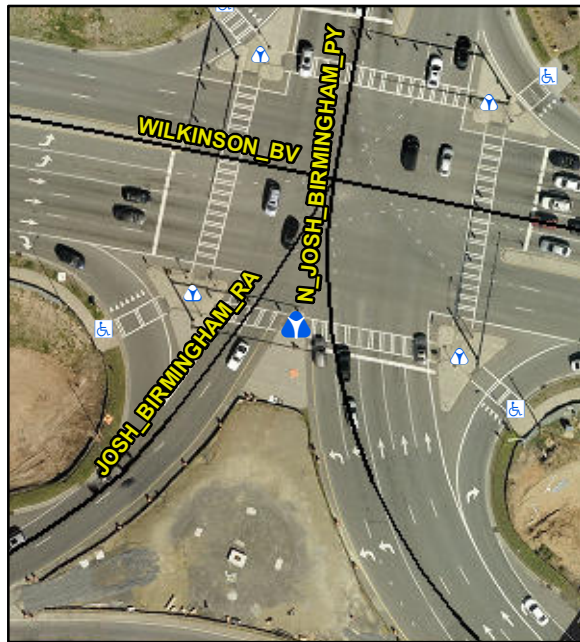
Compliance	Description	Data	Compliance	Description	Data
Yes	Refuge 1 Length (In)	55.5	Yes	Gutter 1 Ponding?	No
Yes	Refuge 1 Width (In)	94.0	Yes	Gutter 1 Lip Ht (In)	0.0
Yes	Refuge 1 Slope (%)	1.7	Yes	Gutter 1 Slope (%)	0.3
Yes	Refuge 1 X Slope (%)	1.2	Yes	Gutter 1 X Slope (%)	1.0
N/A	Painted X Walk1?	Yes	Yes	DWS 1 Provided?	Yes
N/A	X Walk 1 Direction	To E	Yes	DWS 1 Contrast?	Yes
N/A	X Walk 1 Width (In)	105.0	Yes	DWS 1 Length (In)	24.0
N/A	Road 1 Slope (%)	0.2	Yes	DWS 1 Full Width?	Yes
N/A	Road 1 X Slope (%)	0.5	Yes	DWS 1 Offset (In)	0.0
Yes	Refuge 2 Length (In)	55.5	Yes	Gutter 2 Ponding?	No
Yes	Refuge 2 Width (In)	94.0	Yes	Gutter 2 Lip Ht (In)	0.0
Yes	Refuge 2 Slope (%)	2.0	Yes	Gutter 2 Slope (%)	0.5
Yes	Refuge 2 X Slope (%)	1.8	No	Gutter 2 X Slope (%)	3.1
N/A	Painted X Walk2?	Yes	Yes	DWS 2 Provided?	Yes
N/A	X Walk 2 Direction	To W	Yes	DWS 2 Contrast?	Yes
N/A	X Walk 2 Width (In)	112.0	Yes	DWS 2 Length (In)	24.0

N/A	Road 2 Slope (%)	1.9	Yes	DWS 2 Full Width?	Yes
N/A	Road 2 X Slope (%)	3.1	Yes	DWS 2 Offset (In)	0.0
N/A	Refuge 3 Length (in)	N/A	N/A	Gutter 3 Ponding?	N/A
N/A	Refuge 3 Width (in)	N/A	N/A	Gutter 3 Lip Ht (in)	N/A
N/A	Refuge 3 Slope (%)	N/A	N/A	Gutter 3 Slope (%)	N/A
N/A	Refuge 3 XSlope (%)	N/A	N/A	Gutter 3 XSlope (%)	N/A
N/A	Painted X Walk3?	N/A	N/A	DWS 3 Provided?	N/A
N/A	X Walk 3 Direction	N/A	N/A	DWS 3 Contrast?	N/A
N/A	X Walk 3 Width (in)	N/A	N/A	DWS 3 Length (in)	N/A
N/A	Road 3 Slope (%)	N/A	N/A	DWS 3 Full Width?	N/A
N/A	Road 3 XSlope (%)	N/A	N/A	DWS 3 Offset (in)	N/A
Yes	Any Obstructions?	No	N/A	Storm Grate/Utility Hazard?	No
N/A	Obstruction Type		N/A	Storm Grate/Utility Type	
		N/A			N/A
N/A	Surface Condition	Good

**Remove & Replace Gutter.**

Total Cost: \$ 750.00
