Access Compliance Report

Public Rights-of-Way

(Island Curb Cuts)

Intersection ID: 10942	Main Street: S I-77 EXIT 10B_RA	Cross Street: S I-77 EXIT 10C_RA	Location: W
ADA ID: DA2FAF4B2401	Curb Cut Type: MedianRefuge2	Initial Pass/Fail: Fail	Overall Compliance: No
Severity Score: 1.25			
Codes/Mitigation Info/Possible Solution		Field Measurements/Component Compliance

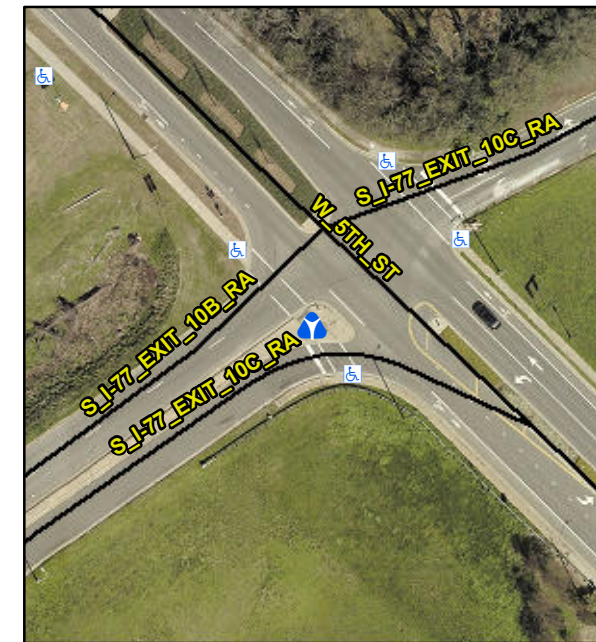
Compliance	Description	Data	Compliance	Description	Data
Yes	Refuge 1 Length (In)	90.0	N/A	Gutter 1 Ponding?	N/A
Yes	Refuge 1 Width (In)	90.0	N/A	Gutter 1 Lip Ht (In)	N/A
Yes	Refuge 1 Slope (%)	1.7	N/A	Gutter 1 Slope (%)	N/A
Yes	Refuge 1 X Slope (%)	2.9	N/A	Gutter 1 X Slope (%)	N/A
N/A	Painted X Walk1?	Yes	N/A	DWS 1 Provided?	N/A
N/A	X Walk 1 Direction	To SE	N/A	DWS 1 Contrast?	N/A
N/A	X Walk 1 Width (In)	112.0	N/A	DWS 1 Length (In)	N/A
N/A	Road 1 Slope (%)	3.0	N/A	DWS 1 Full Width?	N/A
N/A	Road 1 X Slope (%)	2.1	N/A	DWS 1 Offset (In)	N/A
Yes	Refuge 2 Length (In)	90.0	N/A	Gutter 2 Ponding?	N/A
Yes	Refuge 2 Width (In)	90.0	N/A	Gutter 2 Lip Ht (In)	N/A
Yes	Refuge 2 Slope (%)	3.2	N/A	Gutter 2 Slope (%)	N/A
Yes	Refuge 2 X Slope (%)	1.3	N/A	Gutter 2 X Slope (%)	N/A
N/A	Painted X Walk2?	Yes	N/A	DWS 2 Provided?	N/A
N/A	X Walk 2 Direction	To NW	N/A	DWS 2 Contrast?	N/A
N/A	X Walk 2 Width (In)	112.0	N/A	DWS 2 Length (In)	N/A

N/A	Road 2 Slope (%)	2.7	N/A	DWS 2 Full Width?	N/A
N/A	Road 2 X Slope (%)	1.6	N/A	DWS 2 Offset (In)	N/A
N/A	Refuge 3 Length (in)	N/A	N/A	Gutter 3 Ponding?	N/A
N/A	Refuge 3 Width (in)	N/A	N/A	Gutter 3 Lip Ht (in)	N/A
N/A	Refuge 3 Slope (%)	N/A	N/A	Gutter 3 Slope (%)	N/A
N/A	Refuge 3 XSlope (%)	N/A	N/A	Gutter 3 XSlope (%)	N/A
N/A	Painted X Walk3?	N/A	N/A	DWS 3 Provided?	N/A
N/A	X Walk 3 Direction	N/A	N/A	DWS 3 Contrast?	N/A
N/A	X Walk 3 Width (in)	N/A	N/A	DWS 3 Length (in)	N/A
N/A	Road 3 Slope (%)	N/A	N/A	DWS 3 Full Width?	N/A
N/A	Road 3 XSlope (%)	N/A	N/A	DWS 3 Offset (in)	N/A
Yes	Any Obstructions?	N/A	N/A	Storm Grate/Utility Hazard?	N/A
N/A	Obstruction Type		N/A	Storm Grate/Utility Type	
		N/A			N/A
N/A	Surface Condition	Good

Possible Solutions:

Remove & Replace Entire Refuge.
