Access Compliance Report

Public Rights-of-Way

(Island Curb Cuts)

Intersection ID: 10022037	Main Street: BRYANT_FARMS_RD	Cross Street: N/A	Location: S
ADA ID: DA8CCC07D807	Curb Cut Type: MedianRefuge2	Initial Pass/Fail: Fail	Overall Compliance: No
Codes/Mitigation Info/Possible Solution		Field Measurements/Component Compliance

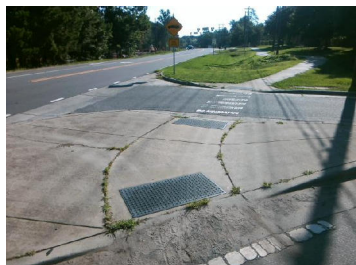
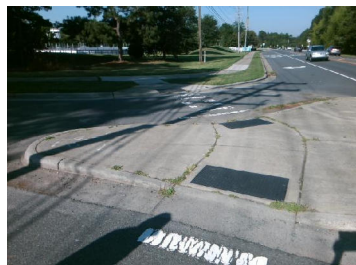
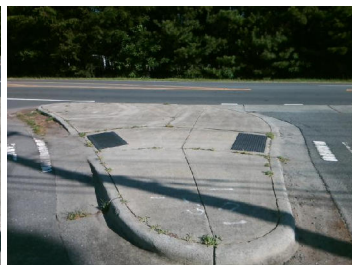
Compliance	Description	Data	Compliance	Description	Data
Yes	Refuge 1 Length (In)	72.5	N/A	Gutter 1 Ponding?	N/A
No	Refuge 1 Width (In)	59.0	N/A	Gutter 1 Lip Ht (In)	N/A
Yes	Refuge 1 Slope (%)	0.4	N/A	Gutter 1 Slope (%)	N/A
Yes	Refuge 1 X Slope (%)	2.5	N/A	Gutter 1 X Slope (%)	N/A
N/A	Painted X Walk1?	Yes	N/A	DWS 1 Provided?	N/A
N/A	X Walk 1 Direction	To SE	N/A	DWS 1 Contrast?	N/A
N/A	X Walk 1 Width (In)	48.0	N/A	DWS 1 Length (In)	N/A
N/A	Road 1 Slope (%)	0.5	N/A	DWS 1 Full Width?	N/A
N/A	Road 1 X Slope (%)	2.1	N/A	DWS 1 Offset (In)	N/A
Yes	Refuge 2 Length (In)	72.5	N/A	Gutter 2 Ponding?	N/A
No	Refuge 2 Width (In)	59.0	N/A	Gutter 2 Lip Ht (In)	N/A
Yes	Refuge 2 Slope (%)	4.4	N/A	Gutter 2 Slope (%)	N/A
Yes	Refuge 2 X Slope (%)	0.7	N/A	Gutter 2 X Slope (%)	N/A
N/A	Painted X Walk2?	Yes	N/A	DWS 2 Provided?	N/A
N/A	X Walk 2 Direction	To SW	N/A	DWS 2 Contrast?	N/A
N/A	X Walk 2 Width (In)	48.0	N/A	DWS 2 Length (In)	N/A

Remove & Replace Entire Refuge.
