# Access Compliance Report

## Public Rights-of-Way

### (Island Curb Cuts)

Intersection ID: 52918	Main Street: HOOVER_CREEK_BV	Cross Street: STEELE_CREEK_RD	Location: NW
ADA ID: DAF945C60F4D	Curb Cut Type: MedianRefuge2	Initial Pass/Fail: Fail	Overall Compliance: No
Codes/Mitigation Info/Possible Solution		Field Measurements/Component Compliance	
Severity Score: 10

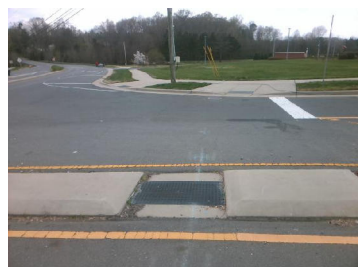
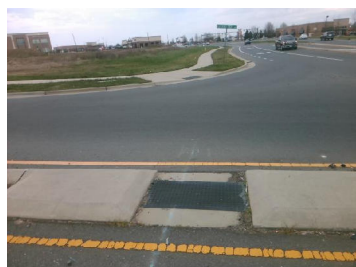
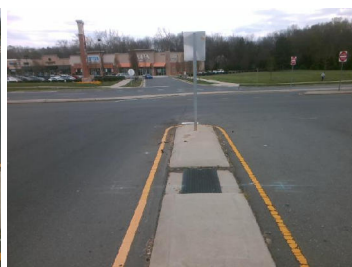
Compliance	Description	Data	Compliance	Description	Data
No	Refuge 1 Length (In)	24.0	N/A	Gutter 1 Ponding?	N/A
No	Refuge 1 Width (In)	48.0	N/A	Gutter 1 Lip Ht (In)	N/A
Yes	Refuge 1 Slope (%)	1.9	N/A	Gutter 1 Slope (%)	N/A
Yes	Refuge 1 X Slope (%)	3.3	N/A	Gutter 1 X Slope (%)	N/A
N/A	Painted X Walk1?	No	N/A	DWS 1 Provided?	N/A
N/A	X Walk 1 Direction	To SW	N/A	DWS 1 Contrast?	N/A
N/A	X Walk 1 Width (In)	N/A	N/A	DWS 1 Length (In)	N/A
N/A	Road 1 Slope (%)	3.6	N/A	DWS 1 Full Width?	N/A
N/A	Road 1 X Slope (%)	2.3	N/A	DWS 1 Offset (In)	N/A
No	Refuge 2 Length (In)	24.0	N/A	Gutter 2 Ponding?	N/A
No	Refuge 2 Width (In)	48.0	N/A	Gutter 2 Lip Ht (In)	N/A
Yes	Refuge 2 Slope (%)	2.4	N/A	Gutter 2 Slope (%)	N/A
Yes	Refuge 2 X Slope (%)	2.3	N/A	Gutter 2 X Slope (%)	N/A
N/A	Painted X Walk2?	No	N/A	DWS 2 Provided?	N/A
N/A	X Walk 2 Direction	To NE	N/A	DWS 2 Contrast?	N/A
N/A	X Walk 2 Width (In)	N/A	N/A	DWS 2 Length (In)	N/A

**Remove & Replace Entire Refuge.**
