Access Compliance Report

Public Rights-of-Way

(Island Curb Cuts)

Intersection ID: 15201	Main Street: ALBEMARLE_RD	Cross Street: LAWYERS_RD	Location: N
ADA ID: DB06AE1D1358	Curb Cut Type: MedianRefuge2	Initial Pass/Fail: Fail	Overall Compliance: No
Codes/Mitigation Info/Possible Solution		Field Measurements/Component Compliance	
Severity Score: 0

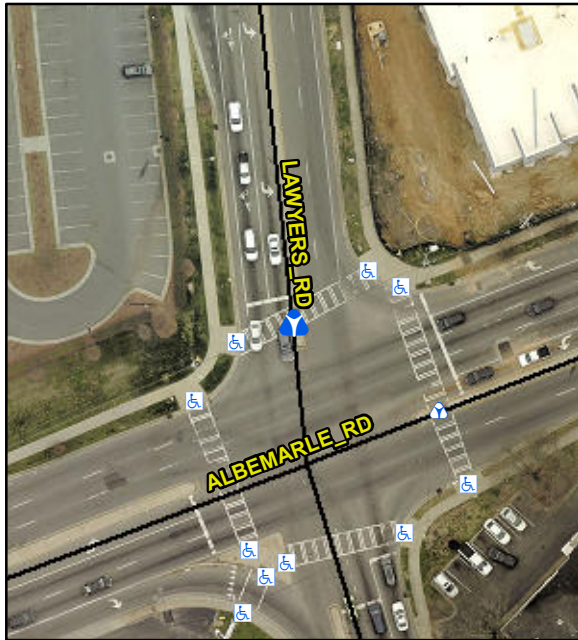
Compliance	Description	Data	Compliance	Description	Data
No	Refuge 1 Length (In)	25.0	N/A	Gutter 1 Ponding?	N/A
Yes	Refuge 1 Width (In)	127.0	N/A	Gutter 1 Lip Ht (In)	N/A
Yes	Refuge 1 Slope (%)	0.4	N/A	Gutter 1 Slope (%)	N/A
Yes	Refuge 1 X Slope (%)	2.5	N/A	Gutter 1 X Slope (%)	N/A
N/A	Painted X Walk1?	Yes	N/A	DWS 1 Provided?	N/A
N/A	X Walk 1 Direction	To SW	N/A	DWS 1 Contrast?	N/A
N/A	X Walk 1 Width (In)	119.0	N/A	DWS 1 Length (In)	N/A
N/A	Road 1 Slope (%)	2.2	N/A	DWS 1 Full Width?	N/A
N/A	Road 1 X Slope (%)	0.9	N/A	DWS 1 Offset (In)	N/A
No	Refuge 2 Length (In)	25.0	N/A	Gutter 2 Ponding?	N/A
Yes	Refuge 2 Width (In)	127.0	N/A	Gutter 2 Lip Ht (In)	N/A
Yes	Refuge 2 Slope (%)	0.5	N/A	Gutter 2 Slope (%)	N/A
Yes	Refuge 2 X Slope (%)	2.7	N/A	Gutter 2 X Slope (%)	N/A
N/A	Painted X Walk2?	Yes	N/A	DWS 2 Provided?	N/A
N/A	X Walk 2 Direction	To NE	N/A	DWS 2 Contrast?	N/A
N/A	X Walk 2 Width (In)	119.0	N/A	DWS 2 Length (In)	N/A

Remove & Replace Entire Refuge.
