Access Compliance Report

Public Rights-of-Way

(Island Curb Cuts)

Intersection ID: 44850	Main Street: STEELE_CREEK_RD	Cross Street: SHOPTON_RD_WEST	Location: N
ADA ID: DBAD5AD867BE	Curb Cut Type: MedianRefuge2	Initial Pass/Fail: Fail	Overall Compliance: No
Severity Score: 0			
Codes/Mitigation Info/Possible Solution		Field Measurements/Component Compliance

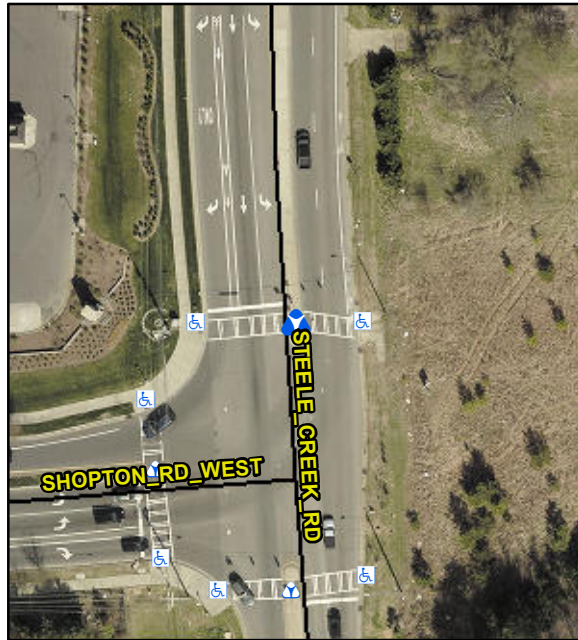
Compliance	Description	Data	Compliance	Description	Data
Yes	Refuge 1 Length (In)	43.5	N/A	Gutter 1 Ponding?	N/A
Yes	Refuge 1 Width (In)	98	N/A	Gutter 1 Lip Ht (In)	N/A
Yes	Refuge 1 Slope (%)	0.3	N/A	Gutter 1 Slope (%)	N/A
Yes	Refuge 1 X Slope (%)	2.4	N/A	Gutter 1 X Slope (%)	N/A
N/A	Painted X Walk1?	Yes	N/A	DWS 1 Provided?	N/A
N/A	X Walk 1 Direction	To E	N/A	DWS 1 Contrast?	N/A
N/A	X Walk 1 Width (In)	114	N/A	DWS 1 Length (In)	N/A
N/A	Road 1 Slope (%)	0.4	N/A	DWS 1 Full Width?	N/A
N/A	Road 1 X Slope (%)	3.9	N/A	DWS 1 Offset (In)	N/A
Yes	Refuge 2 Length (In)	43.5	N/A	Gutter 2 Ponding?	N/A
Yes	Refuge 2 Width (In)	98	N/A	Gutter 2 Lip Ht (In)	N/A
Yes	Refuge 2 Slope (%)	1.3	N/A	Gutter 2 Slope (%)	N/A
Yes	Refuge 2 X Slope (%)	0.8	N/A	Gutter 2 X Slope (%)	N/A
N/A	Painted X Walk2?	Yes	N/A	DWS 2 Provided?	N/A
N/A	X Walk 2 Direction	To W	N/A	DWS 2 Contrast?	N/A
N/A	X Walk 2 Width (In)	112	N/A	DWS 2 Length (In)	N/A

N/A	Road 2 Slope (%)	1.8	N/A	DWS 2 Full Width?	N/A
N/A	Road 2 X Slope (%)	1.1	N/A	DWS 2 Offset (In)	N/A
N/A	Refuge 3 Length (in)	N/A	N/A	Gutter 3 Ponding?	N/A
N/A	Refuge 3 Width (in)	N/A	N/A	Gutter 3 Lip Ht (in)	N/A
N/A	Refuge 3 Slope (%)	N/A	N/A	Gutter 3 Slope (%)	N/A
N/A	Refuge 3 XSlope (%)	N/A	N/A	Gutter 3 XSlope (%)	N/A
N/A	Painted X Walk3?	N/A	N/A	DWS 3 Provided?	N/A
N/A	X Walk 3 Direction	N/A	N/A	DWS 3 Contrast?	N/A
N/A	X Walk 3 Width (in)	N/A	N/A	DWS 3 Length (in)	N/A
N/A	Road 3 Slope (%)	N/A	N/A	DWS 3 Full Width?	N/A
N/A	Road 3 XSlope (%)	N/A	N/A	DWS 3 Offset (in)	N/A
Yes	Any Obstructions?	N/A	N/A	Storm Grate/Utility Hazard?	N/A
N/A	Obstruction Type		N/A	Storm Grate/Utility Type	
		N/A			N/A
N/A	Surface Condition	Good

Remove & Replace Entire Refuge.

\$ 3000.00
