# Access Compliance Report

## Public Rights-of-Way

### (Island Curb Cuts)

Intersection ID: 20654	Main Street: E_INDEPENDENCE_BV	Cross Street: SARDIS_RD_NORTH	Location: SW
ADA ID: DBD0A5F62479	Curb Cut Type: MedianRefuge2	Initial Pass/Fail: Fail	Overall Compliance: No
Severity Score: 1.25			
Codes/Mitigation Info/Possible Solution		Field Measurements/Component Compliance

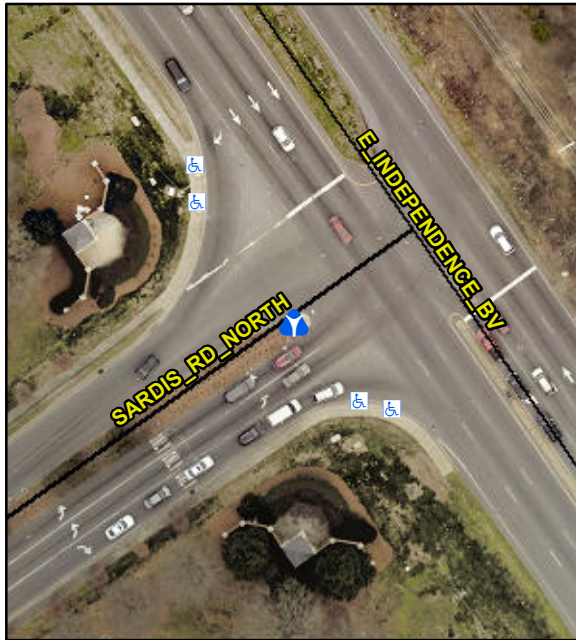
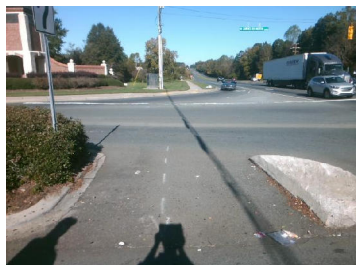
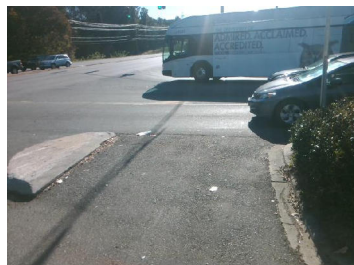
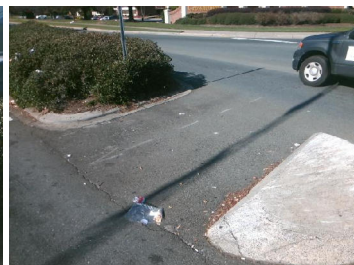
Compliance	Description	Data	Compliance	Description	Data
Yes	Refuge 1 Length (In)	53.5	N/A	Gutter 1 Ponding?	N/A
Yes	Refuge 1 Width (In)	130.0	N/A	Gutter 1 Lip Ht (In)	N/A
Yes	Refuge 1 Slope (%)	2.9	N/A	Gutter 1 Slope (%)	N/A
Yes	Refuge 1 X Slope (%)	2.7	N/A	Gutter 1 X Slope (%)	N/A
N/A	Painted X Walk1?	No	N/A	DWS 1 Provided?	N/A
N/A	X Walk 1 Direction	To NW	N/A	DWS 1 Contrast?	N/A
N/A	X Walk 1 Width (In)	N/A	N/A	DWS 1 Length (In)	N/A
N/A	Road 1 Slope (%)	1.3	N/A	DWS 1 Full Width?	N/A
N/A	Road 1 X Slope (%)	3.2	N/A	DWS 1 Offset (In)	N/A
Yes	Refuge 2 Length (In)	53.5	N/A	Gutter 2 Ponding?	N/A
Yes	Refuge 2 Width (In)	130.0	N/A	Gutter 2 Lip Ht (In)	N/A
Yes	Refuge 2 Slope (%)	2.1	N/A	Gutter 2 Slope (%)	N/A
Yes	Refuge 2 X Slope (%)	3.3	N/A	Gutter 2 X Slope (%)	N/A
N/A	Painted X Walk2?	No	N/A	DWS 2 Provided?	N/A
N/A	X Walk 2 Direction	To SE	N/A	DWS 2 Contrast?	N/A
N/A	X Walk 2 Width (In)	N/A	N/A	DWS 2 Length (In)	N/A

N/A	Road 2 Slope (%)	2.1	N/A	DWS 2 Full Width?	N/A
N/A	Road 2 X Slope (%)	0.1	N/A	DWS 2 Offset (In)	N/A
N/A	Refuge 3 Length (in)	N/A	N/A	Gutter 3 Ponding?	N/A
N/A	Refuge 3 Width (in)	N/A	N/A	Gutter 3 Lip Ht (in)	N/A
N/A	Refuge 3 Slope (%)	N/A	N/A	Gutter 3 Slope (%)	N/A
N/A	Refuge 3 XSlope (%)	N/A	N/A	Gutter 3 XSlope (%)	N/A
N/A	Painted X Walk3?	N/A	N/A	DWS 3 Provided?	N/A
N/A	X Walk 3 Direction	N/A	N/A	DWS 3 Contrast?	N/A
N/A	X Walk 3 Width (in)	N/A	N/A	DWS 3 Length (in)	N/A
N/A	Road 3 Slope (%)	N/A	N/A	DWS 3 Full Width?	N/A
N/A	Road 3 XSlope (%)	N/A	N/A	DWS 3 Offset (in)	N/A
Yes	Any Obstructions?	N/A	N/A	Storm Grate/Utility Hazard?	N/A
N/A	Obstruction Type		N/A	Storm Grate/Utility Type	
		N/A			N/A
N/A	Surface Condition	Good

**Remove & Replace Entire Refuge.**
