Access Compliance Report

Public Rights-of-Way

(Island Curb Cuts)

Intersection ID: 48587	Main Street: STONEY_CREEK_LN	Cross Street: UNIVERSITY_CITY_BV	Location: E
ADA ID: DCAEE19022DF	Curb Cut Type: MedianRefuge2	Initial Pass/Fail: Pass	Overall Compliance: No
Severity Score: 10			
Codes/Mitigation Info/Possible Solution		Field Measurements/Component Compliance

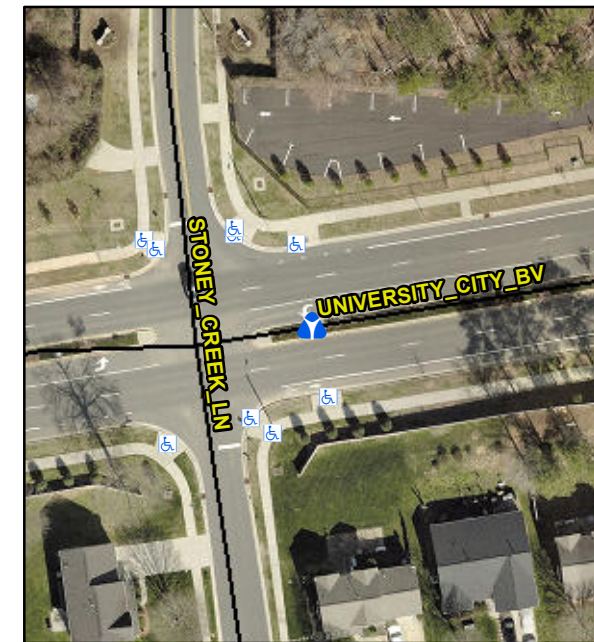
Compliance	Description	Data	Compliance	Description	Data
No	Refuge 1 Length (In)	34.0	Yes	Gutter 1 Ponding?	No
Yes	Refuge 1 Width (In)	94.0	Yes	Gutter 1 Lip Ht (In)	0.0
Yes	Refuge 1 Slope (%)	0.4	No	Gutter 1 Slope (%)	5.8
Yes	Refuge 1 X Slope (%)	1.1	Yes	Gutter 1 X Slope (%)	0.9
N/A	Painted X Walk1?	No	No	DWS 1 Provided?	Yes
N/A	X Walk 1 Direction	To N	N/A	DWS 1 Contrast?	Yes
N/A	X Walk 1 Width (In)	N/A	N/A	DWS 1 Length (In)	24.0
N/A	Road 1 Slope (%)	0.2	N/A	DWS 1 Full Width?	Yes
N/A	Road 1 X Slope (%)	0.2	N/A	DWS 1 Offset (In)	0.0
No	Refuge 2 Length (In)	34.0	Yes	Gutter 2 Ponding?	No
Yes	Refuge 2 Width (In)	94.0	Yes	Gutter 2 Lip Ht (In)	0.0
Yes	Refuge 2 Slope (%)	1.3	Yes	Gutter 2 Slope (%)	2.6
Yes	Refuge 2 X Slope (%)	0.2	Yes	Gutter 2 X Slope (%)	0.8
N/A	Painted X Walk2?	No	No	DWS 2 Provided?	Yes
N/A	X Walk 2 Direction	To S	N/A	DWS 2 Contrast?	Yes
N/A	X Walk 2 Width (In)	N/A	N/A	DWS 2 Length (In)	24.0
N/A	Road 2 Slope (%)	0.6	N/A	DWS 2 Full Width?	Yes

N/A	Road 2 X Slope (%)	2.9	N/A	DWS 2 Offset (In)	0.0
N/A	Refuge 3 Length (in)	N/A	N/A	Gutter 3 Ponding?	No
N/A	Refuge 3 Width (in)	N/A	N/A	Gutter 3 Lip Ht (in)	N/A
N/A	Refuge 3 Slope (%)	N/A	N/A	Gutter 3 Slope (%)	N/A
N/A	Refuge 3 XSlope (%)	N/A	N/A	Gutter 3 XSlope (%)	N/A
N/A	Painted X Walk3?	No	N/A	DWS 3 Provided?	N/A
N/A	X Walk 3 Direction	N/A	N/A	DWS 3 Contrast?	N/A
N/A	X Walk 3 Width (in)	N/A	N/A	DWS 3 Length (in)	N/A
N/A	Road 3 Slope (%)	N/A	N/A	DWS 3 Full Width?	N/A
N/A	Road 3 XSlope (%)	N/A	N/A	DWS 3 Offset (in)	N/A
Yes	Any Obstructions?	No	N/A	Storm Grate/Utility Hazard?	No
N/A	Obstruction Type		N/A	Storm Grate/Utility Type	
		N/A			N/A
N/A	Surface Condition	Good

Remove & Replace Entire Refuge.
Remove & Replace Gutter.
