Access Compliance Report

Public Rights-of-Way

(Island Curb Cuts)

Intersection ID: 48600	Main Street: GRANDIFLORA_DR	Cross Street: LITTLE_GEM_LN	Location:	W
ADA ID: DCC595CBC90B	Curb Cut Type: MedianRefuge2	Initial Pass/Fail: Fail	Overall Compliance: No	Severity Score: 13.75
Codes/Mitigation Info/Possible Solution		Field Measurements/Component Compliance

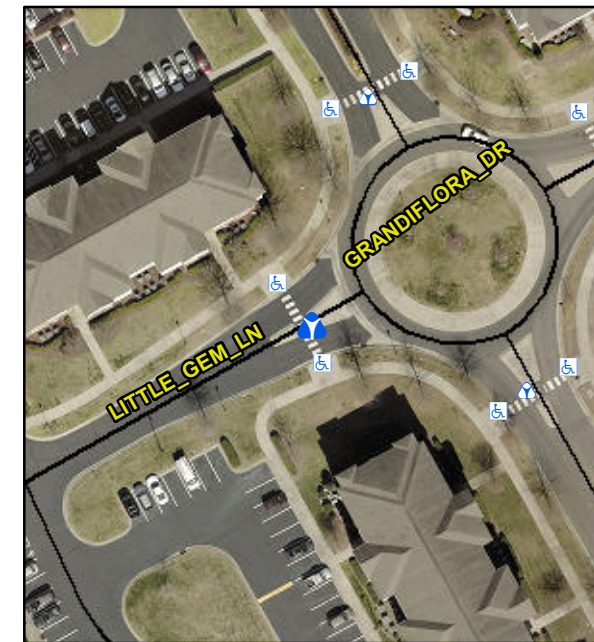
Compliance	Description	Data	Compliance	Description	Data
Yes	Refuge 1 Length (In)	38.5	N/A	Gutter 1 Ponding?	N/A
Yes	Refuge 1 Width (In)	119.0	N/A	Gutter 1 Lip Ht (In)	N/A
Yes	Refuge 1 Slope (%)	2.6	N/A	Gutter 1 Slope (%)	N/A
Yes	Refuge 1 X Slope (%)	2.9	N/A	Gutter 1 X Slope (%)	N/A
N/A	Painted X Walk1?	Yes	N/A	DWS 1 Provided?	N/A
N/A	X Walk 1 Direction	To N	N/A	DWS 1 Contrast?	N/A
N/A	X Walk 1 Width (In)	57.0	N/A	DWS 1 Length (In)	N/A
N/A	Road 1 Slope (%)	0.8	N/A	DWS 1 Full Width?	N/A
N/A	Road 1 X Slope (%)	3.4	N/A	DWS 1 Offset (In)	N/A
Yes	Refuge 2 Length (In)	38.0	N/A	Gutter 2 Ponding?	N/A
Yes	Refuge 2 Width (In)	119.0	N/A	Gutter 2 Lip Ht (In)	N/A
Yes	Refuge 2 Slope (%)	0.0	N/A	Gutter 2 Slope (%)	N/A
No	Refuge 2 X Slope (%)	6.9	N/A	Gutter 2 X Slope (%)	N/A
N/A	Painted X Walk2?	Yes	N/A	DWS 2 Provided?	N/A
N/A	X Walk 2 Direction	To S	N/A	DWS 2 Contrast?	N/A
N/A	X Walk 2 Width (In)	57.0	N/A	DWS 2 Length (In)	N/A

N/A	Road 2 Slope (%)	0.6	N/A	DWS 2 Full Width?	N/A
N/A	Road 2 X Slope (%)	4.3	N/A	DWS 2 Offset (In)	N/A
N/A	Refuge 3 Length (in)	N/A	N/A	Gutter 3 Ponding?	N/A
N/A	Refuge 3 Width (in)	N/A	N/A	Gutter 3 Lip Ht (in)	N/A
N/A	Refuge 3 Slope (%)	N/A	N/A	Gutter 3 Slope (%)	N/A
N/A	Refuge 3 XSlope (%)	N/A	N/A	Gutter 3 XSlope (%)	N/A
N/A	Painted X Walk3?	N/A	N/A	DWS 3 Provided?	N/A
N/A	X Walk 3 Direction	N/A	N/A	DWS 3 Contrast?	N/A
N/A	X Walk 3 Width (in)	N/A	N/A	DWS 3 Length (in)	N/A
N/A	Road 3 Slope (%)	N/A	N/A	DWS 3 Full Width?	N/A
N/A	Road 3 XSlope (%)	N/A	N/A	DWS 3 Offset (in)	N/A
Yes	Any Obstructions?	N/A	N/A	Storm Grate/Utility Hazard?	N/A
N/A	Obstruction Type		N/A	Storm Grate/Utility Type	
		N/A			N/A
N/A	Surface Condition	Good

Possible Solutions:

Remove & Replace Entire Refuge.

Total Cost: \$ 3000.00
