Access Compliance Report

Public Rights-of-Way

(Island Curb Cuts)

Intersection ID: 15394	Main Street: HERMAN_AV	Cross Street: S_TRYON_ST	Location: SE
ADA ID: DCD56A07949B	Curb Cut Type: MedianRefuge2	Initial Pass/Fail: Fail	Overall Compliance: No
Severity Score: 22.5			
Codes/Mitigation Info/Possible Solution		Field Measurements/Component Compliance

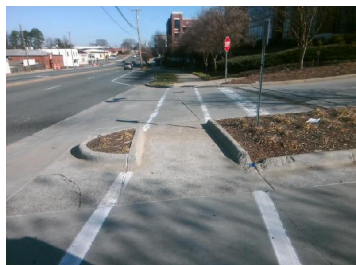
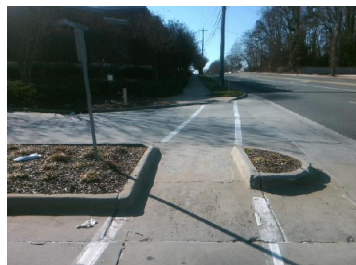
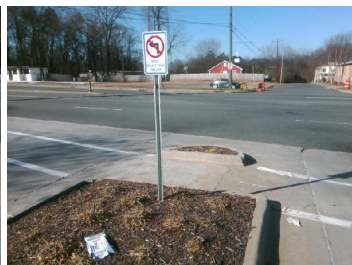
Compliance	Description	Data	Compliance	Description	Data
Yes	Refuge 1 Length (In)	37.5	N/A	Gutter 1 Ponding?	N/A
No	Refuge 1 Width (In)	59.0	N/A	Gutter 1 Lip Ht (In)	N/A
Yes	Refuge 1 Slope (%)	1.9	N/A	Gutter 1 Slope (%)	N/A
Yes	Refuge 1 X Slope (%)	4.0	N/A	Gutter 1 X Slope (%)	N/A
N/A	Painted X Walk1?	Yes	N/A	DWS 1 Provided?	N/A
N/A	X Walk 1 Direction	To SW	N/A	DWS 1 Contrast?	N/A
N/A	X Walk 1 Width (In)	62.0	N/A	DWS 1 Length (In)	N/A
N/A	Road 1 Slope (%)	3.5	N/A	DWS 1 Full Width?	N/A
N/A	Road 1 X Slope (%)	4.0	N/A	DWS 1 Offset (In)	N/A
Yes	Refuge 2 Length (In)	37.5	N/A	Gutter 2 Ponding?	N/A
No	Refuge 2 Width (In)	59.0	N/A	Gutter 2 Lip Ht (In)	N/A
Yes	Refuge 2 Slope (%)	2.3	N/A	Gutter 2 Slope (%)	N/A
No	Refuge 2 X Slope (%)	5.8	N/A	Gutter 2 X Slope (%)	N/A
N/A	Painted X Walk2?	Yes	N/A	DWS 2 Provided?	N/A
N/A	X Walk 2 Direction	To NE	N/A	DWS 2 Contrast?	N/A
N/A	X Walk 2 Width (In)	58.0	N/A	DWS 2 Length (In)	N/A

N/A	Road 2 Slope (%)	6.2	N/A	DWS 2 Full Width?	N/A
N/A	Road 2 X Slope (%)	2.8	N/A	DWS 2 Offset (In)	N/A
N/A	Refuge 3 Length (in)	N/A	N/A	Gutter 3 Ponding?	N/A
N/A	Refuge 3 Width (in)	N/A	N/A	Gutter 3 Lip Ht (in)	N/A
N/A	Refuge 3 Slope (%)	N/A	N/A	Gutter 3 Slope (%)	N/A
N/A	Refuge 3 XSlope (%)	N/A	N/A	Gutter 3 XSlope (%)	N/A
N/A	Painted X Walk3?	N/A	N/A	DWS 3 Provided?	N/A
N/A	X Walk 3 Direction	N/A	N/A	DWS 3 Contrast?	N/A
N/A	X Walk 3 Width (in)	N/A	N/A	DWS 3 Length (in)	N/A
N/A	Road 3 Slope (%)	N/A	N/A	DWS 3 Full Width?	N/A
N/A	Road 3 XSlope (%)	N/A	N/A	DWS 3 Offset (in)	N/A
Yes	Any Obstructions?	N/A	N/A	Storm Grate/Utility Hazard?	N/A
N/A	Obstruction Type		N/A	Storm Grate/Utility Type	
		N/A			N/A
N/A	Surface Condition	Good

Remove & Replace Entire Refuge.
