# Access Compliance Report

## Public Rights-of-Way

### (Island Curb Cuts)

Intersection ID: 20185	Main Street: FAIRVIEW_RD	Cross Street: PIEDMONT_ROW_DR	Location: W
ADA ID: DE41056607D0	Curb Cut Type: MedianRefuge2	Initial Pass/Fail: Fail	Overall Compliance: No
Severity Score: 1.25			
Codes/Mitigation Info/Possible Solution		Field Measurements/Component Compliance

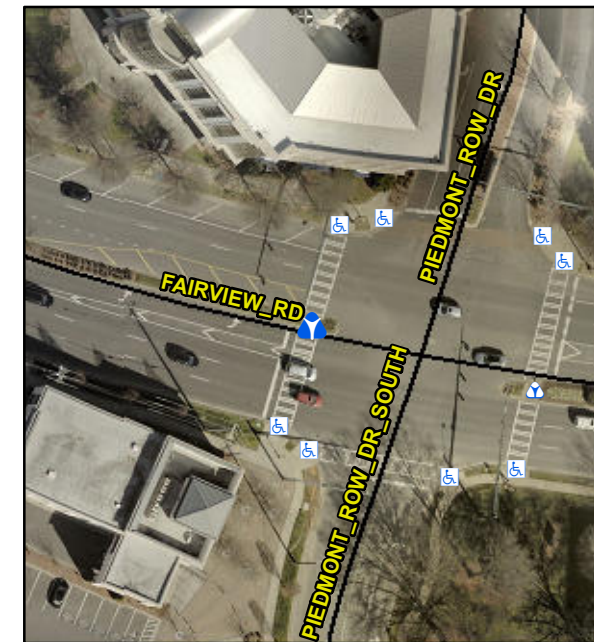
Compliance	Description	Data	Compliance	Description	Data
No	Refuge 1 Length (In)	35.0	N/A	Gutter 1 Ponding?	N/A
Yes	Refuge 1 Width (In)	102.0	N/A	Gutter 1 Lip Ht (In)	N/A
Yes	Refuge 1 Slope (%)	1.1	N/A	Gutter 1 Slope (%)	N/A
Yes	Refuge 1 X Slope (%)	2.7	N/A	Gutter 1 X Slope (%)	N/A
N/A	Painted X Walk1?	Yes	N/A	DWS 1 Provided?	N/A
N/A	X Walk 1 Direction	To NE	N/A	DWS 1 Contrast?	N/A
N/A	X Walk 1 Width (In)	109.0	N/A	DWS 1 Length (In)	N/A
N/A	Road 1 Slope (%)	2.6	N/A	DWS 1 Full Width?	N/A
N/A	Road 1 X Slope (%)	2.4	N/A	DWS 1 Offset (In)	N/A
No	Refuge 2 Length (In)	35.0	N/A	Gutter 2 Ponding?	N/A
Yes	Refuge 2 Width (In)	102.0	N/A	Gutter 2 Lip Ht (In)	N/A
Yes	Refuge 2 Slope (%)	3.3	N/A	Gutter 2 Slope (%)	N/A
Yes	Refuge 2 X Slope (%)	1.3	N/A	Gutter 2 X Slope (%)	N/A
N/A	Painted X Walk2?	Yes	N/A	DWS 2 Provided?	N/A
N/A	X Walk 2 Direction	To SW	N/A	DWS 2 Contrast?	N/A
N/A	X Walk 2 Width (In)	115.0	N/A	DWS 2 Length (In)	N/A

N/A	Road 2 Slope (%)	3.0	N/A	DWS 2 Full Width?	N/A
N/A	Road 2 X Slope (%)	5.1	N/A	DWS 2 Offset (In)	N/A
N/A	Refuge 3 Length (in)	N/A	N/A	Gutter 3 Ponding?	N/A
N/A	Refuge 3 Width (in)	N/A	N/A	Gutter 3 Lip Ht (in)	N/A
N/A	Refuge 3 Slope (%)	N/A	N/A	Gutter 3 Slope (%)	N/A
N/A	Refuge 3 XSlope (%)	N/A	N/A	Gutter 3 XSlope (%)	N/A
N/A	Painted X Walk3?	N/A	N/A	DWS 3 Provided?	N/A
N/A	X Walk 3 Direction	N/A	N/A	DWS 3 Contrast?	N/A
N/A	X Walk 3 Width (in)	N/A	N/A	DWS 3 Length (in)	N/A
N/A	Road 3 Slope (%)	N/A	N/A	DWS 3 Full Width?	N/A
N/A	Road 3 XSlope (%)	N/A	N/A	DWS 3 Offset (in)	N/A
Yes	Any Obstructions?	N/A	N/A	Storm Grate/Utility Hazard?	N/A
N/A	Obstruction Type		N/A	Storm Grate/Utility Type	
		N/A			N/A
N/A	Surface Condition	Good

**Remove & Replace Entire Refuge.**

Total Cost: \$ 3000.00
