Access Compliance Report

Public Rights-of-Way

(Island Curb Cuts)

Intersection ID: 52476	Main Street: WHITEHALL_EXECUTIVE_CENTER_DR	Cross Street: CERNY_DR	Location: NE
ADA ID: DE72D48AA1C9	Curb Cut Type: MedianRefuge2	Initial Pass/Fail: Fail	Overall Compliance: No
Severity Score: 0			
Codes/Mitigation Info/Possible Solution		Field Measurements/Component Compliance

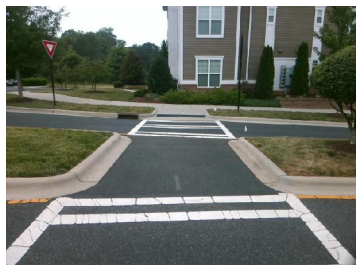
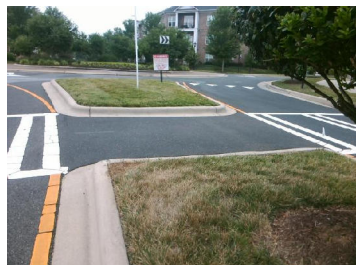
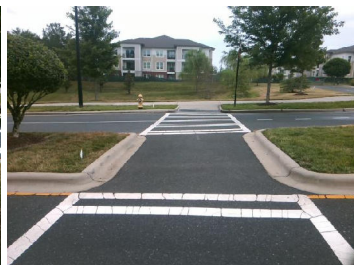
Compliance	Description	Data	Compliance	Description	Data
Yes	Refuge 1 Length (In)	78.0	N/A	Gutter 1 Ponding?	N/A
Yes	Refuge 1 Width (In)	101.0	N/A	Gutter 1 Lip Ht (In)	N/A
Yes	Refuge 1 Slope (%)	0.1	N/A	Gutter 1 Slope (%)	N/A
Yes	Refuge 1 X Slope (%)	4.8	N/A	Gutter 1 X Slope (%)	N/A
N/A	Painted X Walk1?	Yes	N/A	DWS 1 Provided?	N/A
N/A	X Walk 1 Direction	To SE	N/A	DWS 1 Contrast?	N/A
N/A	X Walk 1 Width (In)	113.0	N/A	DWS 1 Length (In)	N/A
N/A	Road 1 Slope (%)	3.5	N/A	DWS 1 Full Width?	N/A
N/A	Road 1 X Slope (%)	1.4	N/A	DWS 1 Offset (In)	N/A
Yes	Refuge 2 Length (In)	78.0	N/A	Gutter 2 Ponding?	N/A
Yes	Refuge 2 Width (In)	101.0	N/A	Gutter 2 Lip Ht (In)	N/A
Yes	Refuge 2 Slope (%)	0.8	N/A	Gutter 2 Slope (%)	N/A
Yes	Refuge 2 X Slope (%)	4.4	N/A	Gutter 2 X Slope (%)	N/A
N/A	Painted X Walk2?	Yes	N/A	DWS 2 Provided?	N/A
N/A	X Walk 2 Direction	To NW	N/A	DWS 2 Contrast?	N/A
N/A	X Walk 2 Width (In)	111.0	N/A	DWS 2 Length (In)	N/A

N/A	Road 2 Slope (%)	3.2	N/A	DWS 2 Full Width?	N/A
N/A	Road 2 X Slope (%)	2.6	N/A	DWS 2 Offset (In)	N/A
N/A	Refuge 3 Length (in)	N/A	N/A	Gutter 3 Ponding?	N/A
N/A	Refuge 3 Width (in)	N/A	N/A	Gutter 3 Lip Ht (in)	N/A
N/A	Refuge 3 Slope (%)	N/A	N/A	Gutter 3 Slope (%)	N/A
N/A	Refuge 3 XSlope (%)	N/A	N/A	Gutter 3 XSlope (%)	N/A
N/A	Painted X Walk3?	N/A	N/A	DWS 3 Provided?	N/A
N/A	X Walk 3 Direction	N/A	N/A	DWS 3 Contrast?	N/A
N/A	X Walk 3 Width (in)	N/A	N/A	DWS 3 Length (in)	N/A
N/A	Road 3 Slope (%)	N/A	N/A	DWS 3 Full Width?	N/A
N/A	Road 3 XSlope (%)	N/A	N/A	DWS 3 Offset (in)	N/A
Yes	Any Obstructions?	N/A	N/A	Storm Grate/Utility Hazard?	N/A
N/A	Obstruction Type		N/A	Storm Grate/Utility Type	
		N/A			N/A
N/A	Surface Condition	Good

Remove & Replace Entire Refuge.

\$ 3000.00
