Access Compliance Report

Public Rights-of-Way

(Island Curb Cuts)

Intersection ID: 10039933	Main Street: TRAVIS_GULCH_DR	Cross Street: N/A	Location: S
ADA ID: DF4631ED2FAA	Curb Cut Type: MedianRefuge2	Initial Pass/Fail: Fail	Overall Compliance: No
		Severity Score: 10

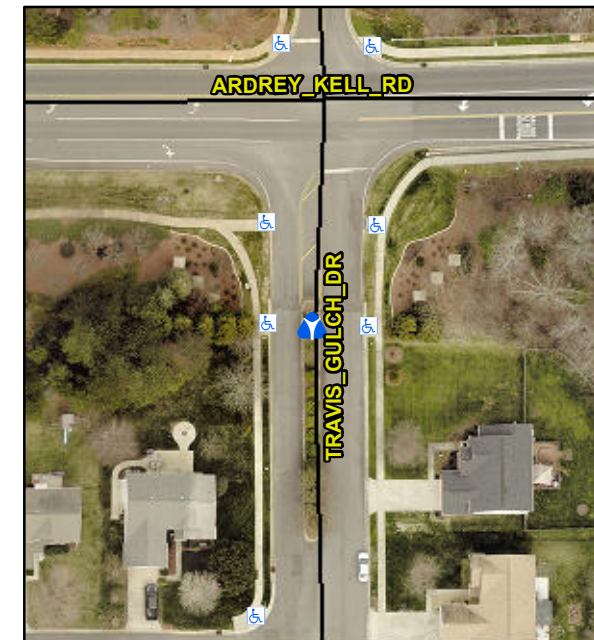
Compliance	Description	Data	Compliance	Description	Data
Yes	Refuge 1 Length (In)	40.5	N/A	Gutter 1 Ponding?	N/A
No	Refuge 1 Width (In)	48.0	N/A	Gutter 1 Lip Ht (In)	N/A
Yes	Refuge 1 Slope (%)	1.3	N/A	Gutter 1 Slope (%)	N/A
Yes	Refuge 1 X Slope (%)	3.4	N/A	Gutter 1 X Slope (%)	N/A
N/A	Painted X Walk1?	No	N/A	DWS 1 Provided?	N/A
N/A	X Walk 1 Direction	To W	N/A	DWS 1 Contrast?	N/A
N/A	X Walk 1 Width (In)	N/A	N/A	DWS 1 Length (In)	N/A
N/A	Road 1 Slope (%)	4.2	N/A	DWS 1 Full Width?	N/A
N/A	Road 1 X Slope (%)	0.3	N/A	DWS 1 Offset (In)	N/A
Yes	Refuge 2 Length (In)	40.5	N/A	Gutter 2 Ponding?	N/A
No	Refuge 2 Width (In)	48.0	N/A	Gutter 2 Lip Ht (In)	N/A
Yes	Refuge 2 Slope (%)	2.7	N/A	Gutter 2 Slope (%)	N/A
Yes	Refuge 2 X Slope (%)	1.3	N/A	Gutter 2 X Slope (%)	N/A
N/A	Painted X Walk2?	No	N/A	DWS 2 Provided?	N/A
N/A	X Walk 2 Direction	To E	N/A	DWS 2 Contrast?	N/A
N/A	X Walk 2 Width (In)	N/A	N/A	DWS 2 Length (In)	N/A

N/A	Road 2 Slope (%)	3.4	N/A	DWS 2 Full Width?	N/A
N/A	Road 2 X Slope (%)	2.1	N/A	DWS 2 Offset (In)	N/A
N/A	Refuge 3 Length (in)	N/A	N/A	Gutter 3 Ponding?	N/A
N/A	Refuge 3 Width (in)	N/A	N/A	Gutter 3 Lip Ht (in)	N/A
N/A	Refuge 3 Slope (%)	N/A	N/A	Gutter 3 Slope (%)	N/A
N/A	Refuge 3 XSlope (%)	N/A	N/A	Gutter 3 XSlope (%)	N/A
N/A	Painted X Walk3?	N/A	N/A	DWS 3 Provided?	N/A
N/A	X Walk 3 Direction	N/A	N/A	DWS 3 Contrast?	N/A
N/A	X Walk 3 Width (in)	N/A	N/A	DWS 3 Length (in)	N/A
N/A	Road 3 Slope (%)	N/A	N/A	DWS 3 Full Width?	N/A
N/A	Road 3 XSlope (%)	N/A	N/A	DWS 3 Offset (in)	N/A
Yes	Any Obstructions?	N/A	N/A	Storm Grate/Utility Hazard?	N/A
N/A	Obstruction Type		N/A	Storm Grate/Utility Type	
		N/A			N/A
N/A	Surface Condition	Good

Remove & Replace Entire Refuge.
