Access Compliance Report

Public Rights-of-Way

(Island Curb Cuts)

Intersection ID: 10952	Main Street: N_GRAHAM_ST	Cross Street: STATESVILLE_AV	Location: E
ADA ID: DF5A70AFA4F3	Curb Cut Type: MedianRefuge2	Initial Pass/Fail: Pass	Overall Compliance: No
Severity Score: 5.25			
Codes/Mitigation Info/Possible Solution		Field Measurements/Component Compliance

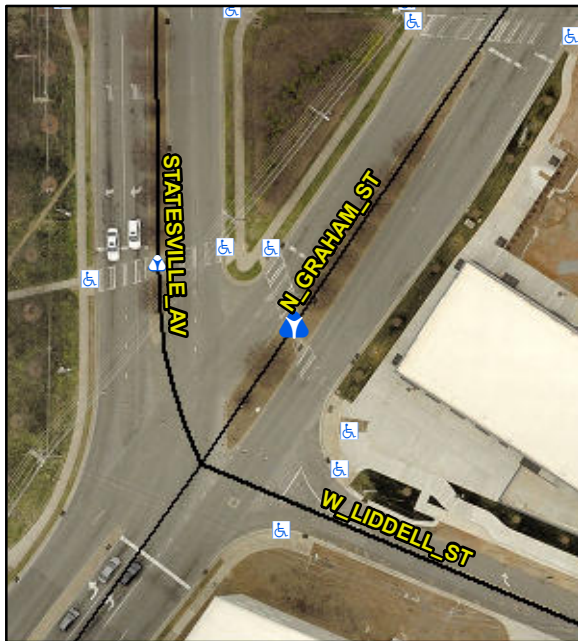
Compliance	Description	Data	Compliance	Description	Data
Yes	Refuge 1 Length (In)	123.0	Yes	Gutter 1 Ponding?	No
Yes	Refuge 1 Width (In)	67.0	Yes	Gutter 1 Lip Ht (In)	0.0
Yes	Refuge 1 Slope (%)	2.4	Yes	Gutter 1 Slope (%)	1.8
Yes	Refuge 1 X Slope (%)	0.7	Yes	Gutter 1 X Slope (%)	1.5
N/A	Painted X Walk1?	Yes	Yes	DWS 1 Provided?	Yes
N/A	X Walk 1 Direction	To SE	Yes	DWS 1 Contrast?	Yes
N/A	X Walk 1 Width (In)	135.5	Yes	DWS 1 Length (In)	25.5
N/A	Road 1 Slope (%)	0.9	No	DWS 1 Full Width?	No
N/A	Road 1 X Slope (%)	3.6	Yes	DWS 1 Offset (In)	2.0
Yes	Refuge 2 Length (In)	123.0	Yes	Gutter 2 Ponding?	No
Yes	Refuge 2 Width (In)	68.0	Yes	Gutter 2 Lip Ht (In)	0.0
Yes	Refuge 2 Slope (%)	0.2	Yes	Gutter 2 Slope (%)	1.2
Yes	Refuge 2 X Slope (%)	0.3	Yes	Gutter 2 X Slope (%)	0.4
N/A	Painted X Walk2?	Yes	Yes	DWS 2 Provided?	Yes
N/A	X Walk 2 Direction	To NW	Yes	DWS 2 Contrast?	Yes
N/A	X Walk 2 Width (In)	132.5	Yes	DWS 2 Length (In)	25.5

N/A	Road 2 Slope (%)	1.0	No	DWS 2 Full Width?	No
N/A	Road 2 X Slope (%)	2.8	Yes	DWS 2 Offset (In)	2.0
N/A	Refuge 3 Length (in)	N/A	N/A	Gutter 3 Ponding?	No
N/A	Refuge 3 Width (in)	N/A	N/A	Gutter 3 Lip Ht (in)	N/A
N/A	Refuge 3 Slope (%)	N/A	N/A	Gutter 3 Slope (%)	N/A
N/A	Refuge 3 XSlope (%)	N/A	N/A	Gutter 3 XSlope (%)	N/A
N/A	Painted X Walk3?	No	N/A	DWS 3 Provided?	N/A
N/A	X Walk 3 Direction	N/A	N/A	DWS 3 Contrast?	N/A
N/A	X Walk 3 Width (in)	N/A	N/A	DWS 3 Length (in)	N/A
N/A	Road 3 Slope (%)	N/A	N/A	DWS 3 Full Width?	N/A
N/A	Road 3 XSlope (%)	N/A	N/A	DWS 3 Offset (in)	N/A
Yes	Any Obstructions?	No	N/A	Storm Grate/Utility Hazard?	No
N/A	Obstruction Type		N/A	Storm Grate/Utility Type	
		N/A			N/A
N/A	Surface Condition	Good

Remove & Replace Detectable Warning System.
