Access Compliance Report

Public Rights-of-Way

(Island Curb Cuts)

Intersection ID: 10040093	Main Street: TUCKASEEGEE_RD	Cross Street: N/A	Location: N
ADA ID: E03B7182DBD5	Curb Cut Type: MedianRefuge2	Initial Pass/Fail: Fail	Overall Compliance: No
Codes/Mitigation Info/Possible Solution		Field Measurements/Component Compliance

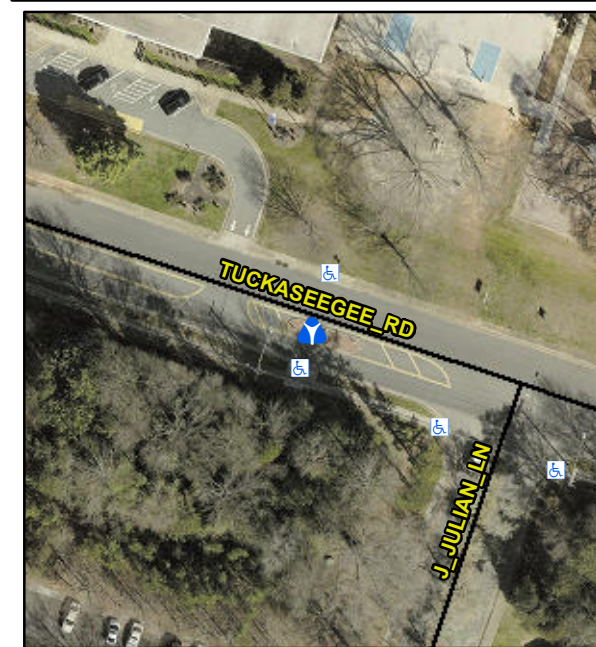
Compliance	Description	Data	Compliance	Description	Data
Yes	Refuge 1 Length (In)	54.0	N/A	Gutter 1 Ponding?	N/A
Yes	Refuge 1 Width (In)	100.0	N/A	Gutter 1 Lip Ht (In)	N/A
Yes	Refuge 1 Slope (%)	1.6	N/A	Gutter 1 Slope (%)	N/A
Yes	Refuge 1 X Slope (%)	0.7	N/A	Gutter 1 X Slope (%)	N/A
N/A	Painted X Walk1?	No	N/A	DWS 1 Provided?	N/A
N/A	X Walk 1 Direction	To N	N/A	DWS 1 Contrast?	N/A
N/A	X Walk 1 Width (In)	N/A	N/A	DWS 1 Length (In)	N/A
N/A	Road 1 Slope (%)	0.6	N/A	DWS 1 Full Width?	N/A
N/A	Road 1 X Slope (%)	0.1	N/A	DWS 1 Offset (In)	N/A
Yes	Refuge 2 Length (In)	54.0	N/A	Gutter 2 Ponding?	N/A
Yes	Refuge 2 Width (In)	100.0	N/A	Gutter 2 Lip Ht (In)	N/A
Yes	Refuge 2 Slope (%)	4.9	N/A	Gutter 2 Slope (%)	N/A
Yes	Refuge 2 X Slope (%)	2.1	N/A	Gutter 2 X Slope (%)	N/A
N/A	Painted X Walk2?	No	N/A	DWS 2 Provided?	N/A
N/A	X Walk 2 Direction	To S	N/A	DWS 2 Contrast?	N/A
N/A	X Walk 2 Width (In)	N/A	N/A	DWS 2 Length (In)	N/A

N/A	Road 2 Slope (%)	1.0	N/A	DWS 2 Full Width?	N/A
N/A	Road 2 X Slope (%)	6.0	N/A	DWS 2 Offset (In)	N/A
N/A	Refuge 3 Length (in)	N/A	N/A	Gutter 3 Ponding?	N/A
N/A	Refuge 3 Width (in)	N/A	N/A	Gutter 3 Lip Ht (in)	N/A
N/A	Refuge 3 Slope (%)	N/A	N/A	Gutter 3 Slope (%)	N/A
N/A	Refuge 3 XSlope (%)	N/A	N/A	Gutter 3 XSlope (%)	N/A
N/A	Painted X Walk3?	N/A	N/A	DWS 3 Provided?	N/A
N/A	X Walk 3 Direction	N/A	N/A	DWS 3 Contrast?	N/A
N/A	X Walk 3 Width (in)	N/A	N/A	DWS 3 Length (in)	N/A
N/A	Road 3 Slope (%)	N/A	N/A	DWS 3 Full Width?	N/A
N/A	Road 3 XSlope (%)	N/A	N/A	DWS 3 Offset (in)	N/A
Yes	Any Obstructions?	N/A	N/A	Storm Grate/Utility Hazard?	N/A
N/A	Obstruction Type		N/A	Storm Grate/Utility Type	
		N/A			N/A
N/A	Surface Condition	Good

Remove & Replace Entire Refuge.
