Access Compliance Report

Public Rights-of-Way

(Island Curb Cuts)

Intersection ID: 10036062	Main Street: RIVERGATE_PY	Cross Street: N/A	Location: SE
ADA ID: E0C65F8B9ACC	Curb Cut Type: MedianRefuge2	Initial Pass/Fail: Fail	Overall Compliance: No
Severity Score: 8.75			
Codes/Mitigation Info/Possible Solution		Field Measurements/Component Compliance

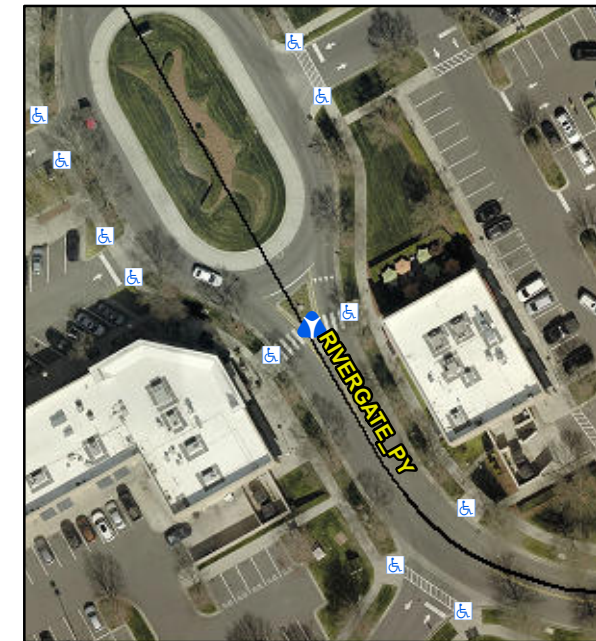
Compliance	Description	Data	Compliance	Description	Data
No	Refuge 1 Length (In)	35.5	N/A	Gutter 1 Ponding?	N/A
No	Refuge 1 Width (In)	51.0	N/A	Gutter 1 Lip Ht (In)	N/A
Yes	Refuge 1 Slope (%)	1.6	N/A	Gutter 1 Slope (%)	N/A
Yes	Refuge 1 X Slope (%)	2.2	N/A	Gutter 1 X Slope (%)	N/A
N/A	Painted X Walk1?	Yes	N/A	DWS 1 Provided?	N/A
N/A	X Walk 1 Direction	To SW	N/A	DWS 1 Contrast?	N/A
N/A	X Walk 1 Width (In)	121.0	N/A	DWS 1 Length (In)	N/A
N/A	Road 1 Slope (%)	2.6	N/A	DWS 1 Full Width?	N/A
N/A	Road 1 X Slope (%)	0.9	N/A	DWS 1 Offset (In)	N/A
No	Refuge 2 Length (In)	35.5	N/A	Gutter 2 Ponding?	N/A
No	Refuge 2 Width (In)	51.0	N/A	Gutter 2 Lip Ht (In)	N/A
Yes	Refuge 2 Slope (%)	1.6	N/A	Gutter 2 Slope (%)	N/A
Yes	Refuge 2 X Slope (%)	1.4	N/A	Gutter 2 X Slope (%)	N/A
N/A	Painted X Walk2?	Yes	N/A	DWS 2 Provided?	N/A
N/A	X Walk 2 Direction	To NE	N/A	DWS 2 Contrast?	N/A
N/A	X Walk 2 Width (In)	120.0	N/A	DWS 2 Length (In)	N/A

Remove & Replace Entire Refuge.
