# Access Compliance Report

## Public Rights-of-Way

### (Island Curb Cuts)

Intersection ID: 53279	Main Street: BENFIELD_RD	Cross Street: N/A	Location:	N
ADA ID: E0D2193FCCC9	Curb Cut Type: MedianRefuge2	Initial Pass/Fail: Pass	Overall Compliance: No	Severity Score: 15

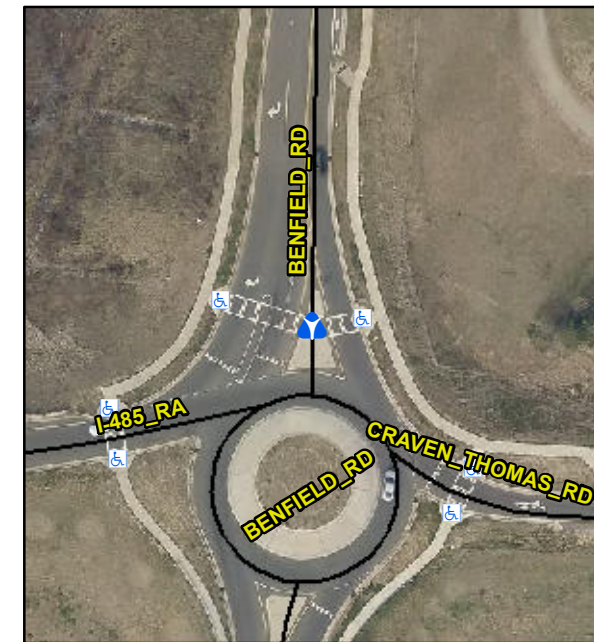
Compliance	Description	Data	Compliance	Description	Data
Yes	Refuge 1 Length (In)	54.0	Yes	Gutter 1 Ponding?	No
Yes	Refuge 1 Width (In)	120.0	Yes	Gutter 1 Lip Ht (In)	0.0
Yes	Refuge 1 Slope (%)	1.3	Yes	Gutter 1 Slope (%)	1.3
Yes	Refuge 1 X Slope (%)	0.1	Yes	Gutter 1 X Slope (%)	1.5
N/A	Painted X Walk1?	Yes	No	DWS 1 Provided?	No
N/A	X Walk 1 Direction	To E	N/A	DWS 1 Contrast?	No
N/A	X Walk 1 Width (In)	106.5	N/A	DWS 1 Length (In)	N/A
N/A	Road 1 Slope (%)	0.3	N/A	DWS 1 Full Width?	No
N/A	Road 1 X Slope (%)	0.4	N/A	DWS 1 Offset (In)	N/A
Yes	Refuge 2 Length (In)	54.0	Yes	Gutter 2 Ponding?	No
Yes	Refuge 2 Width (In)	120.0	Yes	Gutter 2 Lip Ht (In)	0.0
Yes	Refuge 2 Slope (%)	0.3	Yes	Gutter 2 Slope (%)	3.3
Yes	Refuge 2 X Slope (%)	0.7	Yes	Gutter 2 X Slope (%)	0.1
N/A	Painted X Walk2?	Yes	No	DWS 2 Provided?	No
N/A	X Walk 2 Direction	To W	N/A	DWS 2 Contrast?	No
N/A	X Walk 2 Width (In)	105.0	N/A	DWS 2 Length (In)	N/A

N/A	Road 2 Slope (%)	0.0	N/A	DWS 2 Full Width?	No
N/A	Road 2 X Slope (%)	2.7	N/A	DWS 2 Offset (In)	N/A
N/A	Refuge 3 Length (in)	N/A	N/A	Gutter 3 Ponding?	No
N/A	Refuge 3 Width (in)	N/A	N/A	Gutter 3 Lip Ht (in)	N/A
N/A	Refuge 3 Slope (%)	N/A	N/A	Gutter 3 Slope (%)	N/A
N/A	Refuge 3 XSlope (%)	N/A	N/A	Gutter 3 XSlope (%)	N/A
N/A	Painted X Walk3?	No	N/A	DWS 3 Provided?	N/A
N/A	X Walk 3 Direction	N/A	N/A	DWS 3 Contrast?	N/A
N/A	X Walk 3 Width (in)	N/A	N/A	DWS 3 Length (in)	N/A
N/A	Road 3 Slope (%)	N/A	N/A	DWS 3 Full Width?	N/A
N/A	Road 3 XSlope (%)	N/A	N/A	DWS 3 Offset (in)	N/A
Yes	Any Obstructions?	No	N/A	Storm Grate/Utility Hazard?	No
N/A	Obstruction Type		N/A	Storm Grate/Utility Type	
		N/A			N/A
N/A	Surface Condition	Good

**Install Detectable Warning System.**
