# Access Compliance Report

## Public Rights-of-Way

### (Island Curb Cuts)

| Intersection ID: 28291 | Main Street: COMMUNITY HOUSE RD | Cross Street: ARDREY KELL RD | Location: SE |

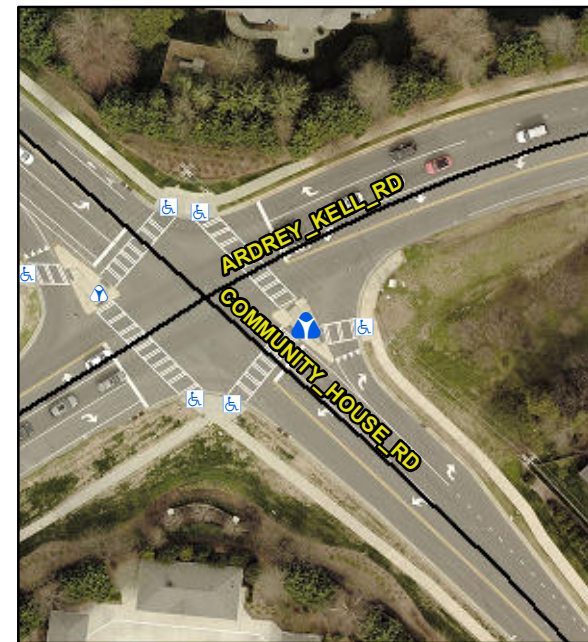
| ADA ID: E2894B18C6C2 | Curb Cut Type: IslandRefuge3 | Initial Pass/Fail: Pass | Overall Compliance: No |
| Severity Score: 5.25 | | | |

| Compliance | Description | Data | Compliance | Description | Data |
|---|---|---|---|---|---|
| N/A | Road 1 X Slope (%) | 1.2 | No | DWS 1 Offset (In) | 6.0 |
| N/A | Road 2 X Slope (%) | 2.6 | No | DWS 2 Offset (In) | 18.0 |
| N/A | Road 3 XSlope (%) | 1.7 | No | DWS 3 Offset (in) | 4.0 |

**Remove & Replace Detectable Warning System.**

Total Cost: \$ 2400.00
