Access Compliance Report

Public Rights-of-Way

(Island Curb Cuts)

Intersection ID: 5832	Main Street: N_TRYON_ST	Cross Street: KEN_HOFFMAN_DR	Location:	N
ADA ID: E2BBF3AABD8E	Curb Cut Type: MedianRefuge2	Initial Pass/Fail: Fail	Overall Compliance: No	Severity Score: 0
Codes/Mitigation Info/Possible Solution		Field Measurements/Component Compliance

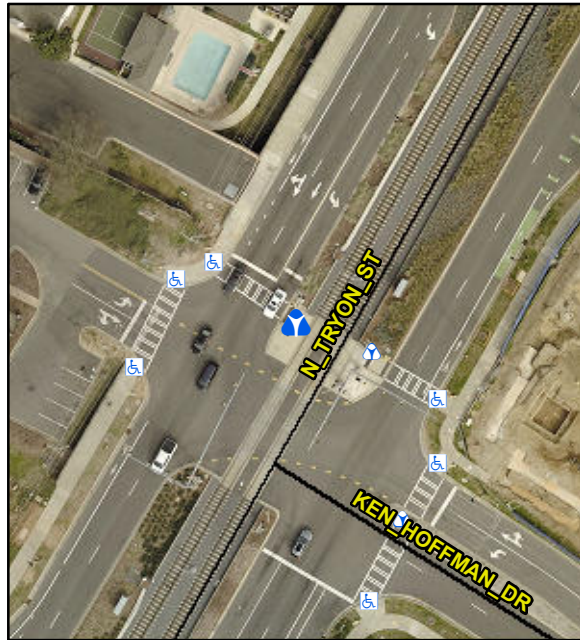
road slopes: 2.1, 2.9

Remove & Replace Entire Refuge.
