Access Compliance Report

Public Rights-of-Way

(Island Curb Cuts)

Intersection ID: 52893	Main Street: TWITTER_LN	Cross Street: SANCTUARY_PL	Location:	N
ADA ID: E564C24D1759	Curb Cut Type: MedianRefuge2	Initial Pass/Fail: Fail	Overall Compliance: No	Severity Score: 8.75
Codes/Mitigation Info/Possible Solution		Field Measurements/Component Compliance

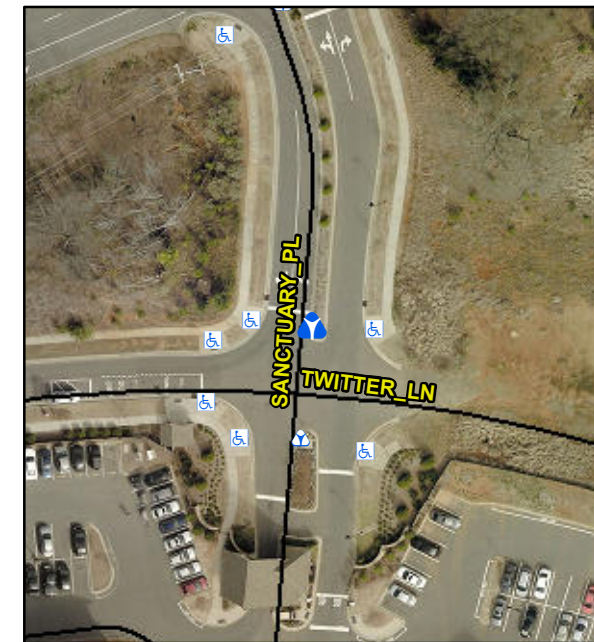
Compliance	Description	Data	Compliance	Description	Data
No	Refuge 1 Length (In)	35.5	N/A	Gutter 1 Ponding?	N/A
No	Refuge 1 Width (In)	48.0	N/A	Gutter 1 Lip Ht (In)	N/A
Yes	Refuge 1 Slope (%)	1.2	N/A	Gutter 1 Slope (%)	N/A
Yes	Refuge 1 X Slope (%)	4.0	N/A	Gutter 1 X Slope (%)	N/A
N/A	Painted X Walk1?	No	N/A	DWS 1 Provided?	N/A
N/A	X Walk 1 Direction	To W	N/A	DWS 1 Contrast?	N/A
N/A	X Walk 1 Width (In)	N/A	N/A	DWS 1 Length (In)	N/A
N/A	Road 1 Slope (%)	4.6	N/A	DWS 1 Full Width?	N/A
N/A	Road 1 X Slope (%)	2.3	N/A	DWS 1 Offset (In)	N/A
No	Refuge 2 Length (In)	35.5	N/A	Gutter 2 Ponding?	N/A
No	Refuge 2 Width (In)	48.0	N/A	Gutter 2 Lip Ht (In)	N/A
Yes	Refuge 2 Slope (%)	0.0	N/A	Gutter 2 Slope (%)	N/A
Yes	Refuge 2 X Slope (%)	2.6	N/A	Gutter 2 X Slope (%)	N/A
N/A	Painted X Walk2?	No	N/A	DWS 2 Provided?	N/A
N/A	X Walk 2 Direction	To E	N/A	DWS 2 Contrast?	N/A
N/A	X Walk 2 Width (In)	N/A	N/A	DWS 2 Length (In)	N/A
N/A	Road 2 Slope (%)	4.3	N/A	DWS 2 Full Width?	N/A

N/A	Road 2 X Slope (%)	3.3	N/A	DWS 2 Offset (In)	N/A
N/A	Refuge 3 Length (in)	N/A	N/A	Gutter 3 Ponding?	N/A
N/A	Refuge 3 Width (in)	N/A	N/A	Gutter 3 Lip Ht (in)	N/A
N/A	Refuge 3 Slope (%)	N/A	N/A	Gutter 3 Slope (%)	N/A
N/A	Refuge 3 XSlope (%)	N/A	N/A	Gutter 3 XSlope (%)	N/A
N/A	Painted X Walk3?	No	N/A	DWS 3 Provided?	N/A
N/A	X Walk 3 Direction	N/A	N/A	DWS 3 Contrast?	N/A
N/A	X Walk 3 Width (in)	N/A	N/A	DWS 3 Length (in)	N/A
N/A	Road 3 Slope (%)	N/A	N/A	DWS 3 Full Width?	N/A
N/A	Road 3 XSlope (%)	N/A	N/A	DWS 3 Offset (in)	N/A
Yes	Any Obstructions?	N/A	N/A	Storm Grate/Utility Hazard?	N/A
N/A	Obstruction Type		N/A	Storm Grate/Utility Type	
		N/A			N/A
N/A	Surface Condition	Good

Remove & Replace Entire Refuge.

\$ 3000.00
