Access Compliance Report

Public Rights-of-Way

(Island Curb Cuts)

Intersection ID: 10032879	Main Street: NATIONS_FORD_RD	Cross Street: N/A	Location: N
ADA ID: E7F3B4FDCABB	Curb Cut Type: MedianRefuge2	Initial Pass/Fail: Pass	Overall Compliance: Yes
Codes/Mitigation Info/Possible Solution		Field Measurements/Component Compliance	
Severity Score: 0.25

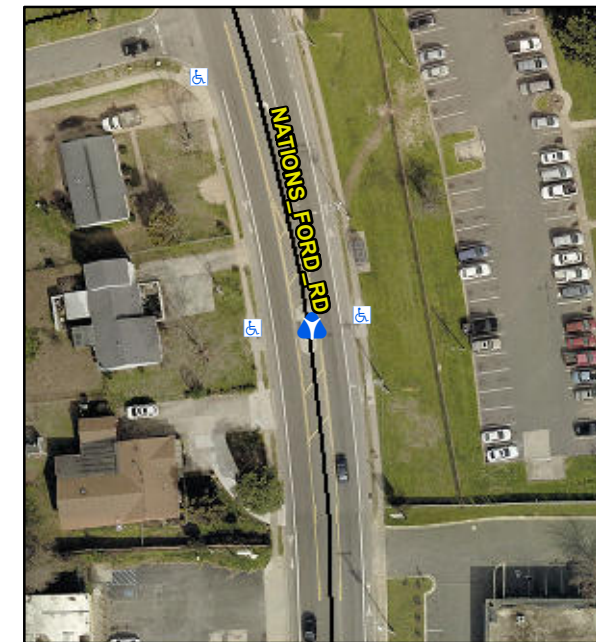
Compliance	Description	Data	Compliance	Description	Data
Yes	Refuge 1 Length (In)	54.0	Yes	Gutter 1 Ponding?	No
Yes	Refuge 1 Width (In)	100.0	Yes	Gutter 1 Lip Ht (In)	0.0
Yes	Refuge 1 Slope (%)	3.2	Yes	Gutter 1 Slope (%)	0.2
Yes	Refuge 1 X Slope (%)	1.1	Yes	Gutter 1 X Slope (%)	0.4
N/A	Painted X Walk1?	No	Yes	DWS 1 Provided?	Yes
N/A	X Walk 1 Direction	To E	Yes	DWS 1 Contrast?	Yes
N/A	X Walk 1 Width (In)	N/A	Yes	DWS 1 Length (In)	24.0
N/A	Road 1 Slope (%)	0.7	Yes	DWS 1 Full Width?	Yes
N/A	Road 1 X Slope (%)	0.6	Yes	DWS 1 Offset (In)	0.0
Yes	Refuge 2 Length (In)	54.0	Yes	Gutter 2 Ponding?	No
Yes	Refuge 2 Width (In)	100.0	Yes	Gutter 2 Lip Ht (In)	0.0
Yes	Refuge 2 Slope (%)	1.8	Yes	Gutter 2 Slope (%)	4.6
Yes	Refuge 2 X Slope (%)	0.5	Yes	Gutter 2 X Slope (%)	0.8
N/A	Painted X Walk2?	No	Yes	DWS 2 Provided?	Yes
N/A	X Walk 2 Direction	To W	Yes	DWS 2 Contrast?	Yes
N/A	X Walk 2 Width (In)	N/A	Yes	DWS 2 Length (In)	24.0

N/A	Road 2 Slope (%)	0.7	Yes	DWS 2 Full Width?	Yes
N/A	Road 2 X Slope (%)	4.6	Yes	DWS 2 Offset (In)	0.0
N/A	Refuge 3 Length (in)	N/A	N/A	Gutter 3 Ponding?	N/A
N/A	Refuge 3 Width (in)	N/A	N/A	Gutter 3 Lip Ht (in)	N/A
N/A	Refuge 3 Slope (%)	N/A	N/A	Gutter 3 Slope (%)	N/A
N/A	Refuge 3 XSlope (%)	N/A	N/A	Gutter 3 XSlope (%)	N/A
N/A	Painted X Walk3?	N/A	N/A	DWS 3 Provided?	N/A
N/A	X Walk 3 Direction	N/A	N/A	DWS 3 Contrast?	N/A
N/A	X Walk 3 Width (in)	N/A	N/A	DWS 3 Length (in)	N/A
N/A	Road 3 Slope (%)	N/A	N/A	DWS 3 Full Width?	N/A
N/A	Road 3 XSlope (%)	N/A	N/A	DWS 3 Offset (in)	N/A
Yes	Any Obstructions?	N/A	N/A	Storm Grate/Utility Hazard?	No
N/A	Obstruction Type		N/A	Storm Grate/Utility Type	
		N/A			N/A
N/A	Surface Condition	Good
