Access Compliance Report

Public Rights-of-Way

(Island Curb Cuts)

Intersection ID: 48492	Main Street: SHOPTON_RD_WEST	Cross Street: BEREWICK_COMMONS_PY	Location: SW
ADA ID: E830CE20F428	Curb Cut Type: MedianRefuge2	Initial Pass/Fail: Fail	Overall Compliance: No
Severity Score: 0			
Codes/Mitigation Info/Possible Solution		Field Measurements/Component Compliance

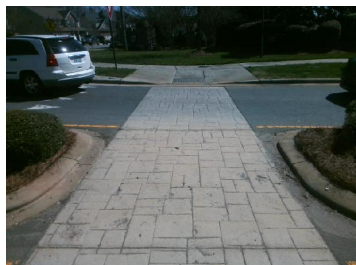
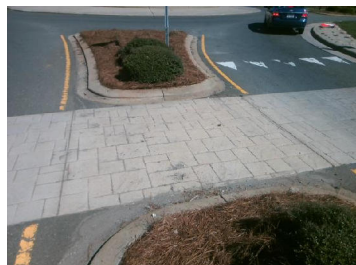
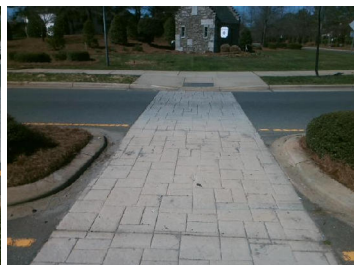
Compliance	Description	Data	Compliance	Description	Data
Yes	Refuge 1 Length (In)	52.0	N/A	Gutter 1 Ponding?	N/A
Yes	Refuge 1 Width (In)	114.0	N/A	Gutter 1 Lip Ht (In)	N/A
Yes	Refuge 1 Slope (%)	0.8	N/A	Gutter 1 Slope (%)	N/A
Yes	Refuge 1 X Slope (%)	2.7	N/A	Gutter 1 X Slope (%)	N/A
N/A	Painted X Walk1?	Yes	N/A	DWS 1 Provided?	N/A
N/A	X Walk 1 Direction	To SE	N/A	DWS 1 Contrast?	N/A
N/A	X Walk 1 Width (In)	99.0	N/A	DWS 1 Length (In)	N/A
N/A	Road 1 Slope (%)	2.3	N/A	DWS 1 Full Width?	N/A
N/A	Road 1 X Slope (%)	1.0	N/A	DWS 1 Offset (In)	N/A
Yes	Refuge 2 Length (In)	52.0	N/A	Gutter 2 Ponding?	N/A
Yes	Refuge 2 Width (In)	114.0	N/A	Gutter 2 Lip Ht (In)	N/A
Yes	Refuge 2 Slope (%)	0.1	N/A	Gutter 2 Slope (%)	N/A
Yes	Refuge 2 X Slope (%)	1.9	N/A	Gutter 2 X Slope (%)	N/A
N/A	Painted X Walk2?	Yes	N/A	DWS 2 Provided?	N/A
N/A	X Walk 2 Direction	To NW	N/A	DWS 2 Contrast?	N/A
N/A	X Walk 2 Width (In)	98.0	N/A	DWS 2 Length (In)	N/A

N/A	Road 2 Slope (%)	0.9	N/A	DWS 2 Full Width?	N/A
N/A	Road 2 X Slope (%)	2.3	N/A	DWS 2 Offset (In)	N/A
N/A	Refuge 3 Length (in)	N/A	N/A	Gutter 3 Ponding?	N/A
N/A	Refuge 3 Width (in)	N/A	N/A	Gutter 3 Lip Ht (in)	N/A
N/A	Refuge 3 Slope (%)	N/A	N/A	Gutter 3 Slope (%)	N/A
N/A	Refuge 3 XSlope (%)	N/A	N/A	Gutter 3 XSlope (%)	N/A
N/A	Painted X Walk3?	N/A	N/A	DWS 3 Provided?	N/A
N/A	X Walk 3 Direction	N/A	N/A	DWS 3 Contrast?	N/A
N/A	X Walk 3 Width (in)	N/A	N/A	DWS 3 Length (in)	N/A
N/A	Road 3 Slope (%)	N/A	N/A	DWS 3 Full Width?	N/A
N/A	Road 3 XSlope (%)	N/A	N/A	DWS 3 Offset (in)	N/A
Yes	Any Obstructions?	N/A	N/A	Storm Grate/Utility Hazard?	N/A
N/A	Obstruction Type		N/A	Storm Grate/Utility Type	
		N/A			N/A
N/A	Surface Condition	Good

Remove & Replace Entire Refuge.
