Access Compliance Report

Public Rights-of-Way

(Island Curb Cuts)

Intersection ID: 53294	Main Street: JOHNSTON_OEHLER_RD	Cross Street: N/A	Location: W
ADA ID: E8F7D4078985	Curb Cut Type: MedianRefuge2	Initial Pass/Fail: Fail	Overall Compliance: No
Codes/Mitigation Info/Possible Solution		Field Measurements/Component Compliance

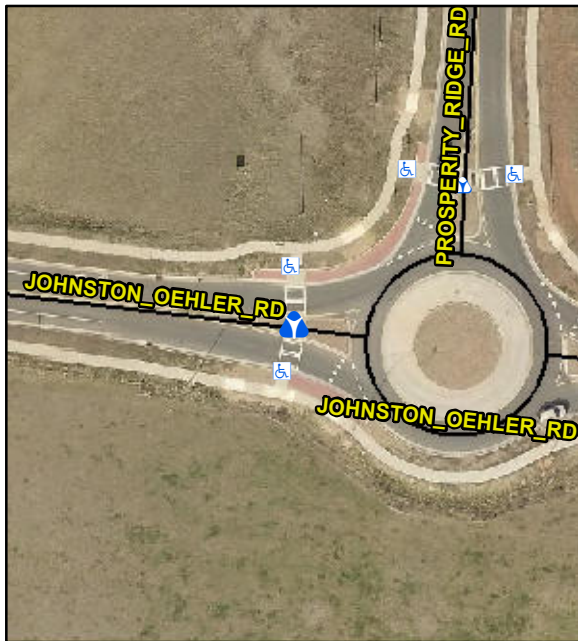
Compliance	Description	Data	Compliance	Description	Data
Yes	Refuge 1 Length (In)	46.0	N/A	Gutter 1 Ponding?	N/A
Yes	Refuge 1 Width (In)	117.0	N/A	Gutter 1 Lip Ht (In)	N/A
Yes	Refuge 1 Slope (%)	0.1	N/A	Gutter 1 Slope (%)	N/A
No	Refuge 1 X Slope (%)	5.4	N/A	Gutter 1 X Slope (%)	N/A
N/A	Painted X Walk1?	Yes	N/A	DWS 1 Provided?	N/A
N/A	X Walk 1 Direction	To N	N/A	DWS 1 Contrast?	N/A
N/A	X Walk 1 Width (In)	112.0	N/A	DWS 1 Length (In)	N/A
N/A	Road 1 Slope (%)	3.5	N/A	DWS 1 Full Width?	N/A
N/A	Road 1 X Slope (%)	1.0	N/A	DWS 1 Offset (In)	N/A
Yes	Refuge 2 Length (In)	43.0	N/A	Gutter 2 Ponding?	N/A
Yes	Refuge 2 Width (In)	117.0	N/A	Gutter 2 Lip Ht (In)	N/A
Yes	Refuge 2 Slope (%)	2.2	N/A	Gutter 2 Slope (%)	N/A
No	Refuge 2 X Slope (%)	5.2	N/A	Gutter 2 X Slope (%)	N/A
N/A	Painted X Walk2?	Yes	N/A	DWS 2 Provided?	N/A
N/A	X Walk 2 Direction	To S	N/A	DWS 2 Contrast?	N/A
N/A	X Walk 2 Width (In)	112.0	N/A	DWS 2 Length (In)	N/A

Remove & Replace Entire Refuge.
