Access Compliance Report

Public Rights-of-Way

(Island Curb Cuts)

| Intersection ID: 18958 | Main Street: GROVER_RD | Cross Street: OLD_PINEVILLE_RD | Location: S |

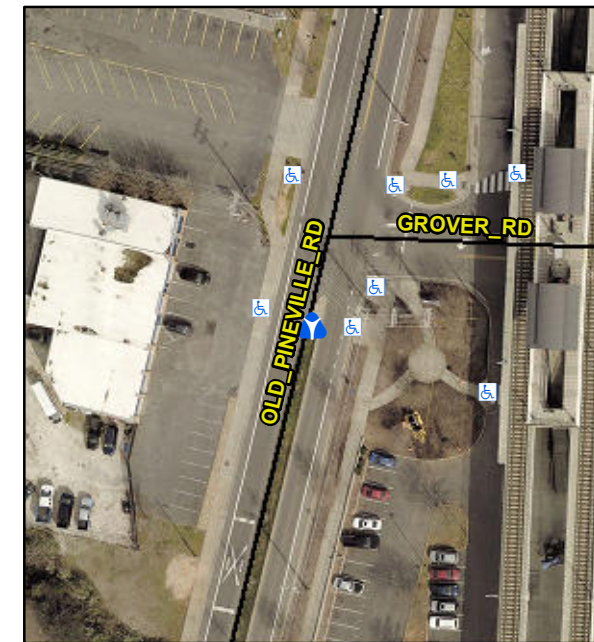
| ADA ID: E91ECDBCDDFB | Curb Cut Type: MedianRefuge2 | Initial Pass/Fail: Pass | Overall Compliance: No |

| Compliance | Description | Data | Compliance | Description | Data |
|---|---|---|---|---|---|
| No | Refuge 1 Length (In) | 33.0 | Yes | Gutter 1 Ponding? | No |
| No | Refuge 2 Length (In) | 33.0 | Yes | Gutter 2 Ponding? | No |

Remove & Replace Entire Refuge.
