Access Compliance Report

Public Rights-of-Way

(Island Curb Cuts)

Intersection ID: 10012508	Main Street: MILTON_RD	Cross Street: N/A	Location: S
ADA ID: EAB03269A7DA	Curb Cut Type: MedianRefuge2	Initial Pass/Fail: Fail	Overall Compliance: No
		Severity Score: 1.25

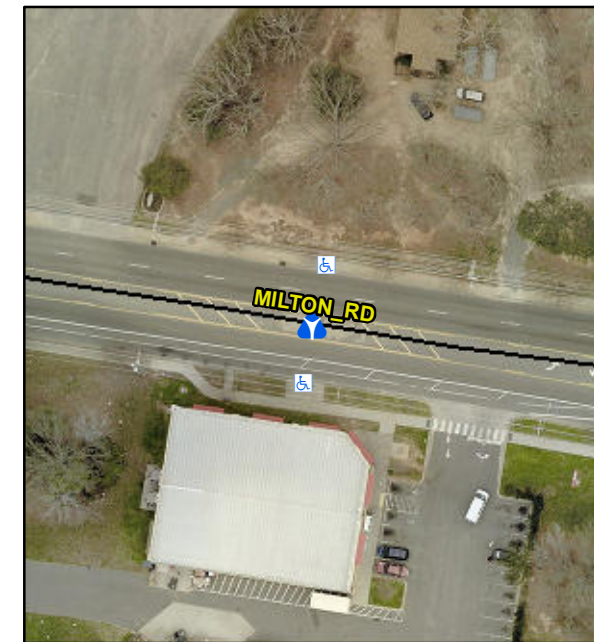
Compliance	Description	Data	Compliance	Description	Data
Yes	Refuge 1 Length (In)	48.0	N/A	Gutter 1 Ponding?	N/A
Yes	Refuge 1 Width (In)	99.0	N/A	Gutter 1 Lip Ht (In)	N/A
Yes	Refuge 1 Slope (%)	1.0	N/A	Gutter 1 Slope (%)	N/A
Yes	Refuge 1 X Slope (%)	2.0	N/A	Gutter 1 X Slope (%)	N/A
N/A	Painted X Walk1?	No	N/A	DWS 1 Provided?	N/A
N/A	X Walk 1 Direction	To S	N/A	DWS 1 Contrast?	N/A
N/A	X Walk 1 Width (In)	N/A	N/A	DWS 1 Length (In)	N/A
N/A	Road 1 Slope (%)	1.9	N/A	DWS 1 Full Width?	N/A
N/A	Road 1 X Slope (%)	1.8	N/A	DWS 1 Offset (In)	N/A
Yes	Refuge 2 Length (In)	48.0	N/A	Gutter 2 Ponding?	N/A
Yes	Refuge 2 Width (In)	99.0	N/A	Gutter 2 Lip Ht (In)	N/A
Yes	Refuge 2 Slope (%)	3.3	N/A	Gutter 2 Slope (%)	N/A
Yes	Refuge 2 X Slope (%)	2.2	N/A	Gutter 2 X Slope (%)	N/A
N/A	Painted X Walk2?	No	N/A	DWS 2 Provided?	N/A
N/A	X Walk 2 Direction	To N	N/A	DWS 2 Contrast?	N/A
N/A	X Walk 2 Width (In)	N/A	N/A	DWS 2 Length (In)	N/A

N/A	Road 2 Slope (%)	1.9	N/A	DWS 2 Full Width?	N/A
N/A	Road 2 X Slope (%)	2.1	N/A	DWS 2 Offset (In)	N/A
N/A	Refuge 3 Length (in)	N/A	N/A	Gutter 3 Ponding?	N/A
N/A	Refuge 3 Width (in)	N/A	N/A	Gutter 3 Lip Ht (in)	N/A
N/A	Refuge 3 Slope (%)	N/A	N/A	Gutter 3 Slope (%)	N/A
N/A	Refuge 3 XSlope (%)	N/A	N/A	Gutter 3 XSlope (%)	N/A
N/A	Painted X Walk3?	N/A	N/A	DWS 3 Provided?	N/A
N/A	X Walk 3 Direction	N/A	N/A	DWS 3 Contrast?	N/A
N/A	X Walk 3 Width (in)	N/A	N/A	DWS 3 Length (in)	N/A
N/A	Road 3 Slope (%)	N/A	N/A	DWS 3 Full Width?	N/A
N/A	Road 3 XSlope (%)	N/A	N/A	DWS 3 Offset (in)	N/A
Yes	Any Obstructions?	N/A	N/A	Storm Grate/Utility Hazard?	N/A
N/A	Obstruction Type		N/A	Storm Grate/Utility Type	
		N/A			N/A
N/A	Surface Condition	Good

Remove & Replace Entire Refuge.

\$ 3000.00
