Access Compliance Report Public Rights-of-Way (Island Curb Cuts)

Intersection ID: 51379 Main Street: BROADRICK BV **Cross Street: UNIVERSITY CITY BV** Location: N ADA ID: EB6623D3CB92 Curb Cut Type: MedianRefuge2 Initial Pass/Fail: Fail **Overall Compliance: No Severity Score:** 25

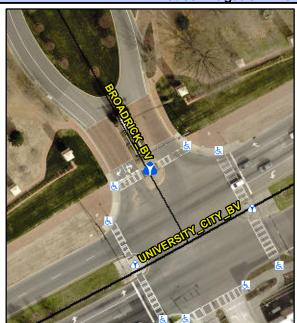
Compliance Description		Data Complian		Description
Yes	Refuge 1 Length (In)	118.0 N/	/A Gutter 1	Ponding?
Yes	Refuge 1 Width (In)	96.0 N/	/A Gutter 1	Lip Ht (In)
No	Refuge 1 Slope (%)	10.0 N/	/A Gutter 1	Slope (%)
Yes	Refuge 1 X Slope (%)	0.1 N/	/A Gutter 1	X Slope (%)
N/A	Painted X Walk1?	Yes N	A DWS 1	Provided?
N/A	X Walk 1 Direction	To SW N/	A DWS 1	Contrast?
N/A	X Walk 1 Width (In)	76.0 N/	A DWS 1	Length (In)
N/A	Road 1 Slope (%)	1.0 N/	A DWS 1	Full Width?
N/A	Road 1 X Slope (%)	1.1 N/	A DWS 1	Offset (In)
Yes	Refuge 2 Length (In)	118.0 N/	A Gutter 2	Ponding?
Yes	Refuge 2 Width (In)	96.0 N/	A Gutter 2	Lip Ht (In)
No	Refuge 2 Slope (%)	10.0 N/	A Gutter 2	Slope (%)
Yes	Refuge 2 X Slope (%)	1.0 N/	A Gutter 2	X Slope (%)
N/A	Painted X Walk2?	Yes N/	A DWS 2	Provided?
N/A	X Walk 2 Direction	To NE N/	A DWS 2	Contrast?
N/A	X Walk 2 Width (In)	76.0 N/	A DWS 2	Length (In)
N/A	Road 2 Slope (%)	0.8 N/	A DWS 2	Full Width?

Remove & Replace Entire Refuge.
