# Access Compliance Report

## Public Rights-of-Way

### (Island Curb Cuts)

Intersection ID: 5421	Main Street: SUNSET_RD	Cross Street: OLD_STATESVILLE_RD	Location: NW
ADA ID: EBA6FA470831	Curb Cut Type: IslandRefuge3	Initial Pass/Fail: Fail	Overall Compliance: No
Severity Score: 60			
Codes/Mitigation Info/Possible Solution		Field Measurements/Component Compliance

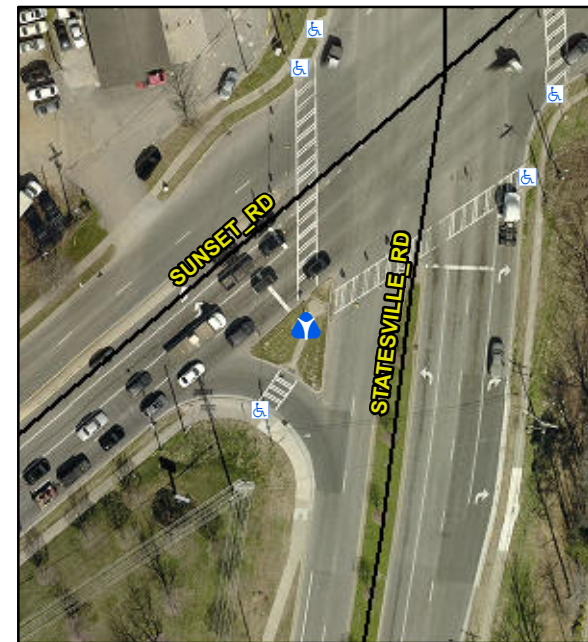
Compliance	Description	Data	Compliance	Description	Data
Yes	Refuge 1 Length (In)	63.0	N/A	Gutter 1 Ponding?	N/A
No	Refuge 1 Width (In)	53.0	N/A	Gutter 1 Lip Ht (In)	N/A
No	Refuge 1 Slope (%)	6.5	N/A	Gutter 1 Slope (%)	N/A
Yes	Refuge 1 X Slope (%)	0.6	N/A	Gutter 1 X Slope (%)	N/A
N/A	Painted X Walk1?	Yes	N/A	DWS 1 Provided?	N/A
N/A	X Walk 1 Direction	To NW	N/A	DWS 1 Contrast?	N/A
N/A	X Walk 1 Width (In)	135.0	N/A	DWS 1 Length (In)	N/A
N/A	Road 1 Slope (%)	0.6	N/A	DWS 1 Full Width?	N/A
N/A	Road 1 X Slope (%)	2.2	N/A	DWS 1 Offset (In)	N/A
Yes	Refuge 2 Length (In)	60.0	N/A	Gutter 2 Ponding?	N/A
Yes	Refuge 2 Width (In)	64.0	N/A	Gutter 2 Lip Ht (In)	N/A
Yes	Refuge 2 Slope (%)	0.7	N/A	Gutter 2 Slope (%)	N/A
Yes	Refuge 2 X Slope (%)	0.9	N/A	Gutter 2 X Slope (%)	N/A
N/A	Painted X Walk2?	Yes	N/A	DWS 2 Provided?	N/A
N/A	X Walk 2 Direction	To NE	N/A	DWS 2 Contrast?	N/A
N/A	X Walk 2 Width (In)	135.0	N/A	DWS 2 Length (In)	N/A

N/A	Road 2 Slope (%)	0.0	N/A	DWS 2 Full Width?	N/A
N/A	Road 2 X Slope (%)	0.1	N/A	DWS 2 Offset (In)	N/A
Yes	Refuge 3 Length (in)	384	N/A	Gutter 3 Ponding?	N/A
No	Refuge 3 Width (in)	51.0	N/A	Gutter 3 Lip Ht (in)	N/A
No	Refuge 3 Slope (%)	10.0	N/A	Gutter 3 Slope (%)	N/A
Yes	Refuge 3 XSlope (%)	0.1	N/A	Gutter 3 XSlope (%)	N/A
N/A	Painted X Walk3?	Yes	N/A	DWS 3 Provided?	N/A
N/A	X Walk 3 Direction	To S	N/A	DWS 3 Contrast?	N/A
N/A	X Walk 3 Width (in)	120.0	N/A	DWS 3 Length (in)	N/A
N/A	Road 3 Slope (%)	0.7	N/A	DWS 3 Full Width?	N/A
N/A	Road 3 XSlope (%)	2.2	N/A	DWS 3 Offset (in)	N/A
Yes	Any Obstructions?	N/A	N/A	Storm Grate/Utility Hazard?	N/A
N/A	Obstruction Type		N/A	Storm Grate/Utility Type	
N/A	Surface Condition	Good	N/A		N/A

**Remove & Replace Entire Refuge.**
