# Access Compliance Report

## Public Rights-of-Way

### (Island Curb Cuts)

Intersection ID: 10035076	Main Street: PROVIDENCE_RD	Cross Street: HEATHERWOODS APARTMENT DR	Location: E
ADA ID: EC7F3BE9DC8B	Curb Cut Type: MedianRefuge2	Initial Pass/Fail: Fail	Overall Compliance: No
		Severity Score: 21.25

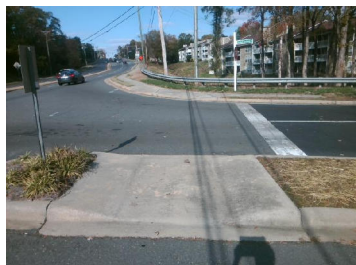
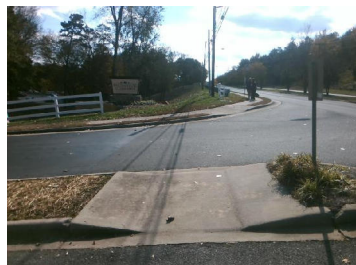
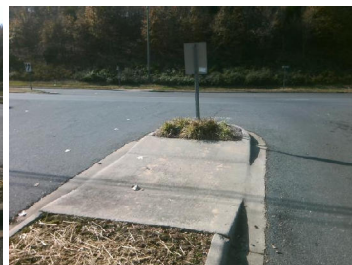
Compliance	Description	Data	Compliance	Description	Data
Yes	Refuge 1 Length (In)	44.5	N/A	Gutter 1 Ponding?	N/A
No	Refuge 1 Width (In)	48.0	N/A	Gutter 1 Lip Ht (In)	N/A
Yes	Refuge 1 Slope (%)	0.1	N/A	Gutter 1 Slope (%)	N/A
No	Refuge 1 X Slope (%)	7.8	N/A	Gutter 1 X Slope (%)	N/A
N/A	Painted X Walk1?	No	N/A	DWS 1 Provided?	N/A
N/A	X Walk 1 Direction	To N	N/A	DWS 1 Contrast?	N/A
N/A	X Walk 1 Width (In)	N/A	N/A	DWS 1 Length (In)	N/A
N/A	Road 1 Slope (%)	8.2	N/A	DWS 1 Full Width?	N/A
N/A	Road 1 X Slope (%)	3.1	N/A	DWS 1 Offset (In)	N/A
Yes	Refuge 2 Length (In)	44.5	N/A	Gutter 2 Ponding?	N/A
No	Refuge 2 Width (In)	48.0	N/A	Gutter 2 Lip Ht (In)	N/A
Yes	Refuge 2 Slope (%)	1.2	N/A	Gutter 2 Slope (%)	N/A
No	Refuge 2 X Slope (%)	9.9	N/A	Gutter 2 X Slope (%)	N/A
N/A	Painted X Walk2?	No	N/A	DWS 2 Provided?	N/A
N/A	X Walk 2 Direction	To S	N/A	DWS 2 Contrast?	N/A
N/A	X Walk 2 Width (In)	N/A	N/A	DWS 2 Length (In)	N/A
N/A	Road 2 Slope (%)	9.1	N/A	DWS 2 Full Width?	N/A

N/A	Road 2 X Slope (%)	0.1	N/A	DWS 2 Offset (In)	N/A
N/A	Refuge 3 Length (in)	N/A	N/A	Gutter 3 Ponding?	N/A
N/A	Refuge 3 Width (in)	N/A	N/A	Gutter 3 Lip Ht (in)	N/A
N/A	Refuge 3 Slope (%)	N/A	N/A	Gutter 3 Slope (%)	N/A
N/A	Refuge 3 XSlope (%)	N/A	N/A	Gutter 3 XSlope (%)	N/A
N/A	Painted X Walk3?	N/A	N/A	DWS 3 Provided?	N/A
N/A	X Walk 3 Direction	N/A	N/A	DWS 3 Contrast?	N/A
N/A	X Walk 3 Width (in)	N/A	N/A	DWS 3 Length (in)	N/A
N/A	Road 3 Slope (%)	N/A	N/A	DWS 3 Full Width?	N/A
N/A	Road 3 XSlope (%)	N/A	N/A	DWS 3 Offset (in)	N/A
Yes	Any Obstructions?	N/A	N/A	Storm Grate/Utility Hazard?	N/A
N/A	Obstruction Type		N/A	Storm Grate/Utility Type	
			N/A		N/A
N/A	Surface Condition	Good

**Remove & Replace Entire Refuge.**
