Access Compliance Report

Public Rights-of-Way

(Island Curb Cuts)

Intersection ID: 10035583	Main Street: REAMES_RD	Cross Street: N/A	Location: N
ADA ID: ED6C7E6410D1	Curb Cut Type: MedianRefuge2	Initial Pass/Fail: Pass	Overall Compliance: No
Codes/Mitigation Info/Possible Solution		Field Measurements/Component Compliance

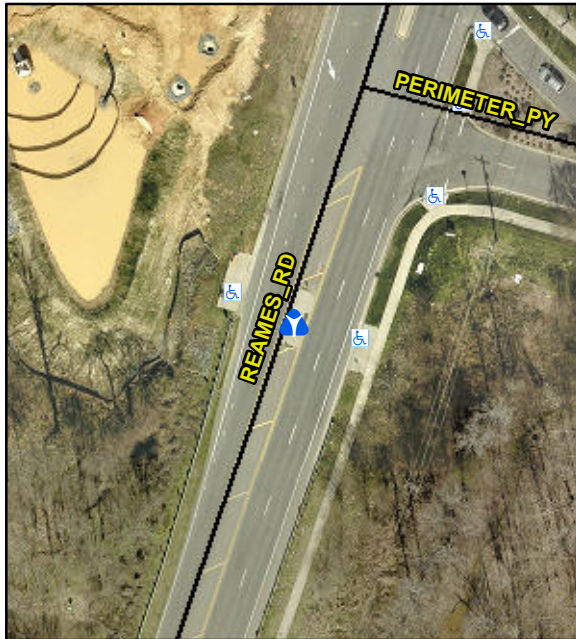
N/A	Road 2 Slope (%)	0.5	Yes	DWS 2 Full Width?	Yes
N/A	Road 2 X Slope (%)	2.6	No	DWS 2 Offset (In)	4.0
N/A	Refuge 3 Length (in)	N/A	N/A	Gutter 3 Ponding?	N/A
N/A	Refuge 3 Width (in)	N/A	N/A	Gutter 3 Lip Ht (in)	N/A
N/A	Refuge 3 Slope (%)	N/A	N/A	Gutter 3 Slope (%)	N/A
N/A	Refuge 3 XSlope (%)	N/A	N/A	Gutter 3 XSlope (%)	N/A
N/A	Painted X Walk3?	N/A	N/A	DWS 3 Provided?	N/A
N/A	X Walk 3 Direction	N/A	N/A	DWS 3 Contrast?	N/A
N/A	X Walk 3 Width (in)	N/A	N/A	DWS 3 Length (in)	N/A
N/A	Road 3 Slope (%)	N/A	N/A	DWS 3 Full Width?	N/A
N/A	Road 3 XSlope (%)	N/A	N/A	DWS 3 Offset (in)	N/A
Yes	Any Obstructions?	No	N/A	Storm Grate/Utility Hazard?	No
N/A	Obstruction Type		N/A	Storm Grate/Utility Type	
		N/A			N/A
N/A	Surface Condition	Good

Remove & Replace Detectable Warning System.
