Access Compliance Report

Public Rights-of-Way

(Island Curb Cuts)

Intersection ID: 51572	Main Street: FREEDOM_DR	Cross Street: WESLEY_VILLAGE_RD	Location: S
ADA ID: EDD852990838	Curb Cut Type: MedianRefuge2	Initial Pass/Fail: Fail	Overall Compliance: No
Codes/Mitigation Info/Possible Solution		Field Measurements/Component Compliance

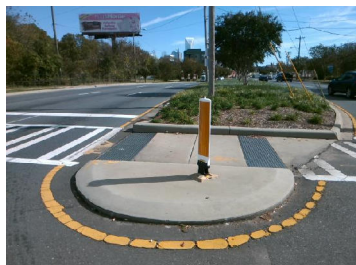
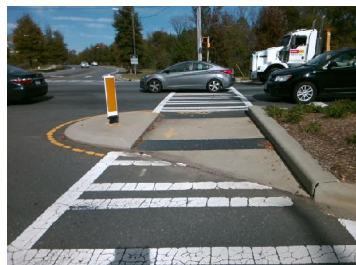
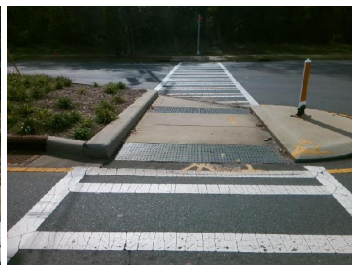
Compliance	Description	Data	Compliance	Description	Data
Yes	Refuge 1 Length (In)	64.0	N/A	Gutter 1 Ponding?	N/A
Yes	Refuge 1 Width (In)	96.0	N/A	Gutter 1 Lip Ht (In)	N/A
Yes	Refuge 1 Slope (%)	4.5	N/A	Gutter 1 Slope (%)	N/A
Yes	Refuge 1 X Slope (%)	2.7	N/A	Gutter 1 X Slope (%)	N/A
N/A	Painted X Walk1?	Yes	N/A	DWS 1 Provided?	N/A
N/A	X Walk 1 Direction	To S	N/A	DWS 1 Contrast?	N/A
N/A	X Walk 1 Width (In)	104.0	N/A	DWS 1 Length (In)	N/A
N/A	Road 1 Slope (%)	0.5	N/A	DWS 1 Full Width?	N/A
N/A	Road 1 X Slope (%)	3.0	N/A	DWS 1 Offset (In)	N/A
Yes	Refuge 2 Length (In)	64.0	N/A	Gutter 2 Ponding?	N/A
Yes	Refuge 2 Width (In)	96.0	N/A	Gutter 2 Lip Ht (In)	N/A
Yes	Refuge 2 Slope (%)	0.6	N/A	Gutter 2 Slope (%)	N/A
Yes	Refuge 2 X Slope (%)	2.0	N/A	Gutter 2 X Slope (%)	N/A
N/A	Painted X Walk2?	Yes	N/A	DWS 2 Provided?	N/A
N/A	X Walk 2 Direction	To N	N/A	DWS 2 Contrast?	N/A
N/A	X Walk 2 Width (In)	104.0	N/A	DWS 2 Length (In)	N/A

N/A	Road 2 Slope (%)	1.7	N/A	DWS 2 Full Width?	N/A
N/A	Road 2 X Slope (%)	7.6	N/A	DWS 2 Offset (In)	N/A
N/A	Refuge 3 Length (in)	N/A	N/A	Gutter 3 Ponding?	N/A
N/A	Refuge 3 Width (in)	N/A	N/A	Gutter 3 Lip Ht (in)	N/A
N/A	Refuge 3 Slope (%)	N/A	N/A	Gutter 3 Slope (%)	N/A
N/A	Refuge 3 XSlope (%)	N/A	N/A	Gutter 3 XSlope (%)	N/A
N/A	Painted X Walk3?	N/A	N/A	DWS 3 Provided?	N/A
N/A	X Walk 3 Direction	N/A	N/A	DWS 3 Contrast?	N/A
N/A	X Walk 3 Width (in)	N/A	N/A	DWS 3 Length (in)	N/A
N/A	Road 3 Slope (%)	N/A	N/A	DWS 3 Full Width?	N/A
N/A	Road 3 XSlope (%)	N/A	N/A	DWS 3 Offset (in)	N/A
Yes	Any Obstructions?	N/A	N/A	Storm Grate/Utility Hazard?	N/A
N/A	Obstruction Type		N/A	Storm Grate/Utility Type	
		N/A			N/A
N/A	Surface Condition	Good

Remove & Replace Entire Refuge.
