Access Compliance Report

Public Rights-of-Way

(Island Curb Cuts)

Intersection ID: 53293	Main Street: PROSPERITY RIDGE RD	Cross Street: N/A	Location: S
ADA ID: EE424C0C0E9B	Curb Cut Type: MedianRefuge2	Initial Pass/Fail: Fail	Overall Compliance: No
			Severity Score: 0

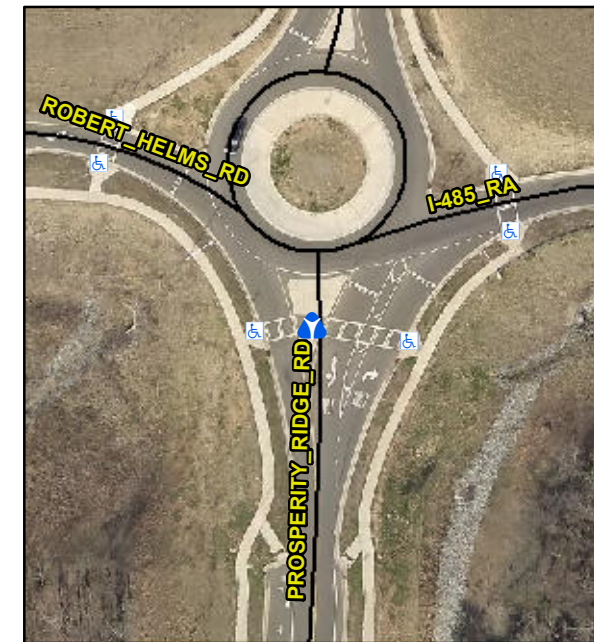
Compliance	Description	Data	Compliance	Description	Data
Yes	Refuge 1 Length (In)	60.0	N/A	Gutter 1 Ponding?	N/A
Yes	Refuge 1 Width (In)	118.0	N/A	Gutter 1 Lip Ht (In)	N/A
Yes	Refuge 1 Slope (%)	1.9	N/A	Gutter 1 Slope (%)	N/A
Yes	Refuge 1 X Slope (%)	4.6	N/A	Gutter 1 X Slope (%)	N/A
N/A	Painted X Walk1?	Yes	N/A	DWS 1 Provided?	N/A
N/A	X Walk 1 Direction	To W	N/A	DWS 1 Contrast?	N/A
N/A	X Walk 1 Width (In)	104.0	N/A	DWS 1 Length (In)	N/A
N/A	Road 1 Slope (%)	4.4	N/A	DWS 1 Full Width?	N/A
N/A	Road 1 X Slope (%)	1.7	N/A	DWS 1 Offset (In)	N/A
Yes	Refuge 2 Length (In)	60.0	N/A	Gutter 2 Ponding?	N/A
Yes	Refuge 2 Width (In)	118.0	N/A	Gutter 2 Lip Ht (In)	N/A
Yes	Refuge 2 Slope (%)	0.3	N/A	Gutter 2 Slope (%)	N/A
Yes	Refuge 2 X Slope (%)	4.9	N/A	Gutter 2 X Slope (%)	N/A
N/A	Painted X Walk2?	Yes	N/A	DWS 2 Provided?	N/A
N/A	X Walk 2 Direction	To E	N/A	DWS 2 Contrast?	N/A
N/A	X Walk 2 Width (In)	106.0	N/A	DWS 2 Length (In)	N/A

N/A	Road 2 Slope (%)	5.2	N/A	DWS 2 Full Width?	N/A
N/A	Road 2 X Slope (%)	3.3	N/A	DWS 2 Offset (In)	N/A
N/A	Refuge 3 Length (in)	N/A	N/A	Gutter 3 Ponding?	N/A
N/A	Refuge 3 Width (in)	N/A	N/A	Gutter 3 Lip Ht (in)	N/A
N/A	Refuge 3 Slope (%)	N/A	N/A	Gutter 3 Slope (%)	N/A
N/A	Refuge 3 XSlope (%)	N/A	N/A	Gutter 3 XSlope (%)	N/A
N/A	Painted X Walk3?	No	N/A	DWS 3 Provided?	N/A
N/A	X Walk 3 Direction	N/A	N/A	DWS 3 Contrast?	N/A
N/A	X Walk 3 Width (in)	N/A	N/A	DWS 3 Length (in)	N/A
N/A	Road 3 Slope (%)	N/A	N/A	DWS 3 Full Width?	N/A
N/A	Road 3 XSlope (%)	N/A	N/A	DWS 3 Offset (in)	N/A
Yes	Any Obstructions?	N/A	N/A	Storm Grate/Utility Hazard?	N/A
N/A	Obstruction Type		N/A	Storm Grate/Utility Type	
		N/A			N/A
N/A	Surface Condition	Good

Remove & Replace Entire Refuge.

\$ 3000.00
