Access Compliance Report

Public Rights-of-Way

(Island Curb Cuts)

Intersection ID: 52582	Main Street: NOBLES_AV	Cross Street: BURNETTE_AV	Location: NE
ADA ID: EE4670AA62C0	Curb Cut Type: MedianRefuge2	Initial Pass/Fail: Fail	Overall Compliance: No
Severity Score: 12.5			
Codes/Mitigation Info/Possible Solution		Field Measurements/Component Compliance

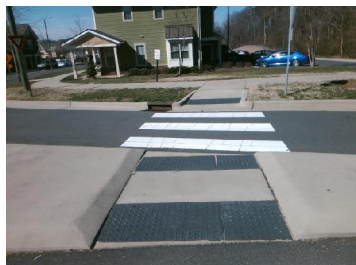
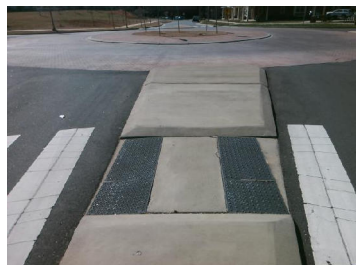
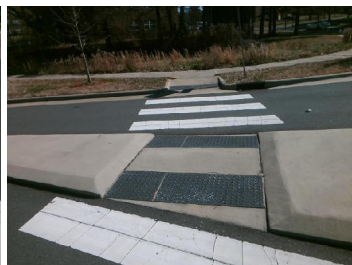
Compliance	Description	Data	Compliance	Description	Data
Yes	Refuge 1 Length (In)	41.0	N/A	Gutter 1 Ponding?	N/A
Yes	Refuge 1 Width (In)	71.0	N/A	Gutter 1 Lip Ht (In)	N/A
No	Refuge 1 Slope (%)	5.1	N/A	Gutter 1 Slope (%)	N/A
Yes	Refuge 1 X Slope (%)	2.7	N/A	Gutter 1 X Slope (%)	N/A
N/A	Painted X Walk1?	Yes	N/A	DWS 1 Provided?	N/A
N/A	X Walk 1 Direction	To NW	N/A	DWS 1 Contrast?	N/A
N/A	X Walk 1 Width (In)	120.0	N/A	DWS 1 Length (In)	N/A
N/A	Road 1 Slope (%)	1.4	N/A	DWS 1 Full Width?	N/A
N/A	Road 1 X Slope (%)	1.6	N/A	DWS 1 Offset (In)	N/A
Yes	Refuge 2 Length (In)	41.0	N/A	Gutter 2 Ponding?	N/A
Yes	Refuge 2 Width (In)	71.0	N/A	Gutter 2 Lip Ht (In)	N/A
Yes	Refuge 2 Slope (%)	4.7	N/A	Gutter 2 Slope (%)	N/A
Yes	Refuge 2 X Slope (%)	0.6	N/A	Gutter 2 X Slope (%)	N/A
N/A	Painted X Walk2?	Yes	N/A	DWS 2 Provided?	N/A
N/A	X Walk 2 Direction	To SE	N/A	DWS 2 Contrast?	N/A
N/A	X Walk 2 Width (In)	120.0	N/A	DWS 2 Length (In)	N/A

Remove & Replace Entire Refuge.
