Access Compliance Report

Public Rights-of-Way

(Island Curb Cuts)

Intersection ID: 6370	Main Street: LAKE_RD	Cross Street: MILHAVEN_LN	Location:	N
ADA ID: EE87D1BF8A9E	Curb Cut Type: MedianRefuge2	Initial Pass/Fail: Pass	Overall Compliance: No	Severity Score: 0
Codes/Mitigation Info/Possible Solution		Field Measurements/Component Compliance

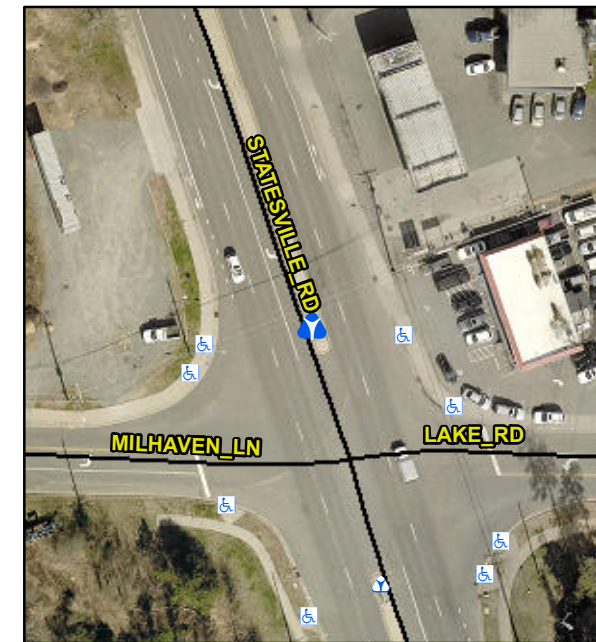
Compliance	Description	Data	Compliance	Description	Data
Yes	Refuge 1 Length (In)	36.0	No	Gutter 1 Ponding?	Yes
Yes	Refuge 1 Width (In)	96.0	No	Gutter 1 Lip Ht (In)	0.25
Yes	Refuge 1 Slope (%)	0.7	Yes	Gutter 1 Slope (%)	3.3
Yes	Refuge 1 X Slope (%)	0.9	Yes	Gutter 1 X Slope (%)	0.2
N/A	Painted X Walk1?	No	Yes	DWS 1 Provided?	Yes
N/A	X Walk 1 Direction	To E	Yes	DWS 1 Contrast?	Yes
N/A	X Walk 1 Width (In)	N/A	Yes	DWS 1 Length (In)	24.0
N/A	Road 1 Slope (%)	0.5	Yes	DWS 1 Full Width?	Yes
N/A	Road 1 X Slope (%)	4.9	Yes	DWS 1 Offset (In)	0.0
Yes	Refuge 2 Length (In)	36.0	No	Gutter 2 Ponding?	Yes
Yes	Refuge 2 Width (In)	96.0	No	Gutter 2 Lip Ht (In)	0.25
Yes	Refuge 2 Slope (%)	1.2	Yes	Gutter 2 Slope (%)	2.7
Yes	Refuge 2 X Slope (%)	1.2	Yes	Gutter 2 X Slope (%)	0.3
N/A	Painted X Walk2?	No	Yes	DWS 2 Provided?	Yes
N/A	X Walk 2 Direction	To W	Yes	DWS 2 Contrast?	Yes
N/A	X Walk 2 Width (In)	N/A	Yes	DWS 2 Length (In)	24.0

N/A	Road 2 Slope (%)	0.4	Yes	DWS 2 Full Width?	Yes
N/A	Road 2 X Slope (%)	2.5	Yes	DWS 2 Offset (In)	0.0
N/A	Refuge 3 Length (in)	N/A	N/A	Gutter 3 Ponding?	No
N/A	Refuge 3 Width (in)	N/A	N/A	Gutter 3 Lip Ht (in)	N/A
N/A	Refuge 3 Slope (%)	N/A	N/A	Gutter 3 Slope (%)	N/A
N/A	Refuge 3 XSlope (%)	N/A	N/A	Gutter 3 XSlope (%)	N/A
N/A	Painted X Walk3?	No	N/A	DWS 3 Provided?	N/A
N/A	X Walk 3 Direction	N/A	N/A	DWS 3 Contrast?	N/A
N/A	X Walk 3 Width (in)	N/A	N/A	DWS 3 Length (in)	N/A
N/A	Road 3 Slope (%)	N/A	N/A	DWS 3 Full Width?	N/A
N/A	Road 3 XSlope (%)	N/A	N/A	DWS 3 Offset (in)	N/A
Yes	Any Obstructions?	No	N/A	Storm Grate/Utility Hazard?	No
N/A	Obstruction Type		N/A	Storm Grate/Utility Type	
		N/A			N/A
N/A	Surface Condition	Good

Possible Solutions:

Grind Gutter Lip.

Total Cost: \$ 400.00
