# Access Compliance Report

## Public Rights-of-Way

### (Island Curb Cuts)

Intersection ID: 14294	Main Street: EAST_BV	Cross Street: EUCLID_AV	Location:	N/A
ADA ID: EEE0D74B2C89	Curb Cut Type: MedianRefuge2	Initial Pass/Fail: Fail	Overall Compliance: No	Severity Score: 12.5
Codes/Mitigation Info/Possible Solution		Field Measurements/Component Compliance

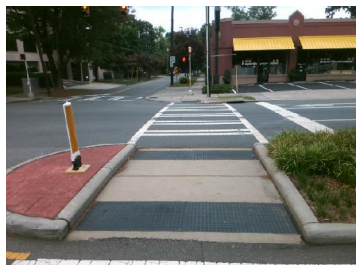
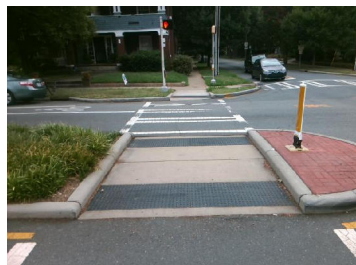
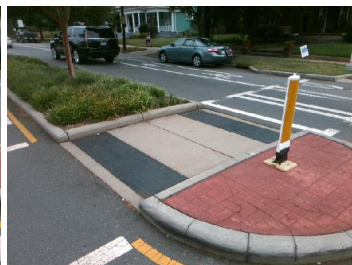
Compliance	Description	Data	Compliance	Description	Data
Yes	Refuge 1 Length (In)	62.5	N/A	Gutter 1 Ponding?	N/A
Yes	Refuge 1 Width (In)	97.5	N/A	Gutter 1 Lip Ht (In)	N/A
Yes	Refuge 1 Slope (%)	3.4	N/A	Gutter 1 Slope (%)	N/A
Yes	Refuge 1 X Slope (%)	0.9	N/A	Gutter 1 X Slope (%)	N/A
N/A	Painted X Walk1?	Yes	N/A	DWS 1 Provided?	N/A
N/A	X Walk 1 Direction	To SW	N/A	DWS 1 Contrast?	N/A
N/A	X Walk 1 Width (In)	113.0	N/A	DWS 1 Length (In)	N/A
N/A	Road 1 Slope (%)	1.1	N/A	DWS 1 Full Width?	N/A
N/A	Road 1 X Slope (%)	1.4	N/A	DWS 1 Offset (In)	N/A
Yes	Refuge 2 Length (In)	62.5	N/A	Gutter 2 Ponding?	N/A
Yes	Refuge 2 Width (In)	97.5	N/A	Gutter 2 Lip Ht (In)	N/A
No	Refuge 2 Slope (%)	5.4	N/A	Gutter 2 Slope (%)	N/A
Yes	Refuge 2 X Slope (%)	1.4	N/A	Gutter 2 X Slope (%)	N/A
N/A	Painted X Walk2?	Yes	N/A	DWS 2 Provided?	N/A
N/A	X Walk 2 Direction	To NE	N/A	DWS 2 Contrast?	N/A
N/A	X Walk 2 Width (In)	112.0	N/A	DWS 2 Length (In)	N/A

N/A	Road 2 Slope (%)	0.8	N/A	DWS 2 Full Width?	N/A
N/A	Road 2 X Slope (%)	2.0	N/A	DWS 2 Offset (In)	N/A
N/A	Refuge 3 Length (in)	N/A	N/A	Gutter 3 Ponding?	N/A
N/A	Refuge 3 Width (in)	N/A	N/A	Gutter 3 Lip Ht (in)	N/A
N/A	Refuge 3 Slope (%)	N/A	N/A	Gutter 3 Slope (%)	N/A
N/A	Refuge 3 XSlope (%)	N/A	N/A	Gutter 3 XSlope (%)	N/A
N/A	Painted X Walk3?	N/A	N/A	DWS 3 Provided?	N/A
N/A	X Walk 3 Direction	N/A	N/A	DWS 3 Contrast?	N/A
N/A	X Walk 3 Width (in)	N/A	N/A	DWS 3 Length (in)	N/A
N/A	Road 3 Slope (%)	N/A	N/A	DWS 3 Full Width?	N/A
N/A	Road 3 XSlope (%)	N/A	N/A	DWS 3 Offset (in)	N/A
Yes	Any Obstructions?	N/A	N/A	Storm Grate/Utility Hazard?	N/A
N/A	Obstruction Type		N/A	Storm Grate/Utility Type	
		N/A			N/A
N/A	Surface Condition	Good

**Remove & Replace Entire Refuge.**
