# Access Compliance Report

## Public Rights-of-Way

### (Island Curb Cuts)

Intersection ID: 16439	Main Street: SOUTH_BV	Cross Street: SCALEYBARK_RD	Location: S
ADA ID: F014B587706C	Curb Cut Type: MedianRefuge2	Initial Pass/Fail: Fail	Overall Compliance: No
Codes/Mitigation Info/Possible Solution		Field Measurements/Component Compliance

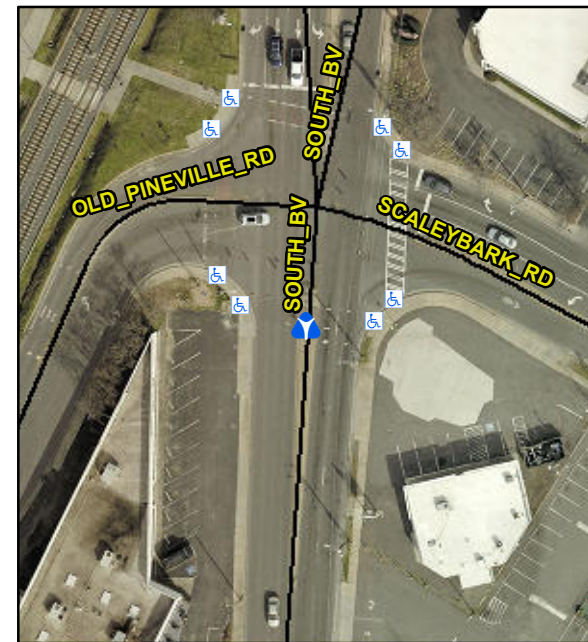
Compliance	Description	Data	Compliance	Description	Data
Yes	Refuge 1 Length (In)	52.0	N/A	Gutter 1 Ponding?	N/A
Yes	Refuge 1 Width (In)	137.0	N/A	Gutter 1 Lip Ht (In)	N/A
No	Refuge 1 Slope (%)	9.3	N/A	Gutter 1 Slope (%)	N/A
Yes	Refuge 1 X Slope (%)	0.6	N/A	Gutter 1 X Slope (%)	N/A
N/A	Painted X Walk1?	Yes	N/A	DWS 1 Provided?	N/A
N/A	X Walk 1 Direction	To E	N/A	DWS 1 Contrast?	N/A
N/A	X Walk 1 Width (In)	112.0	N/A	DWS 1 Length (In)	N/A
N/A	Road 1 Slope (%)	0.5	N/A	DWS 1 Full Width?	N/A
N/A	Road 1 X Slope (%)	5.3	N/A	DWS 1 Offset (In)	N/A
Yes	Refuge 2 Length (In)	52.0	N/A	Gutter 2 Ponding?	N/A
Yes	Refuge 2 Width (In)	137.0	N/A	Gutter 2 Lip Ht (In)	N/A
Yes	Refuge 2 Slope (%)	1.6	N/A	Gutter 2 Slope (%)	N/A
Yes	Refuge 2 X Slope (%)	1.0	N/A	Gutter 2 X Slope (%)	N/A
N/A	Painted X Walk2?	Yes	N/A	DWS 2 Provided?	N/A
N/A	X Walk 2 Direction	To W	N/A	DWS 2 Contrast?	N/A
N/A	X Walk 2 Width (In)	107.0	N/A	DWS 2 Length (In)	N/A

**Remove & Replace Entire Refuge.**

Total Cost: \$ 3000.00
