Access Compliance Report

Public Rights-of-Way

(Island Curb Cuts)

Intersection ID: 10033070	Main Street: NORTH_COMMUNITY_HOUSE_RD	Cross Street: N/A	Location: N
ADA ID: F18A48D94236	Curb Cut Type: MedianRefuge2	Initial Pass/Fail: Fail	Overall Compliance: No
Codes/Mitigation Info/Possible Solution		Field Measurements/Component Compliance

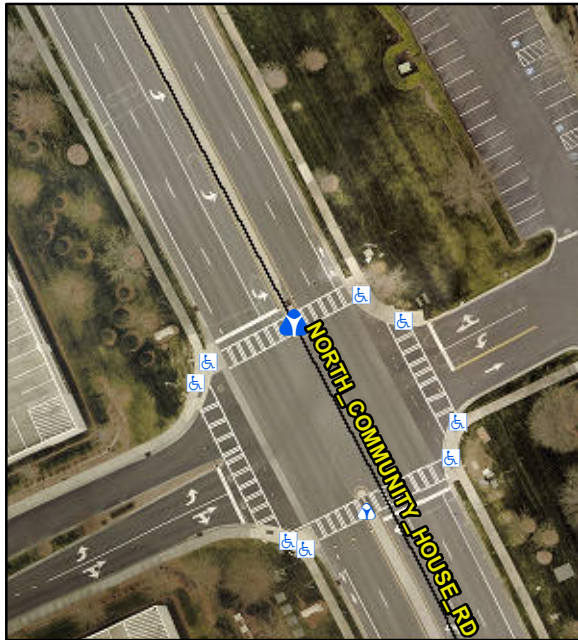
Compliance	Description	Data	Compliance	Description	Data
No	Refuge 1 Length (In)	33.5	N/A	Gutter 1 Ponding?	N/A
Yes	Refuge 1 Width (In)	118.5	N/A	Gutter 1 Lip Ht (In)	N/A
Yes	Refuge 1 Slope (%)	1.9	N/A	Gutter 1 Slope (%)	N/A
Yes	Refuge 1 X Slope (%)	2.3	N/A	Gutter 1 X Slope (%)	N/A
N/A	Painted X Walk1?	Yes	N/A	DWS 1 Provided?	N/A
N/A	X Walk 1 Direction	To SW	N/A	DWS 1 Contrast?	N/A
N/A	X Walk 1 Width (In)	110.0	N/A	DWS 1 Length (In)	N/A
N/A	Road 1 Slope (%)	2.1	N/A	DWS 1 Full Width?	N/A
N/A	Road 1 X Slope (%)	2.4	N/A	DWS 1 Offset (In)	N/A
No	Refuge 2 Length (In)	33.5	N/A	Gutter 2 Ponding?	N/A
Yes	Refuge 2 Width (In)	118.5	N/A	Gutter 2 Lip Ht (In)	N/A
Yes	Refuge 2 Slope (%)	4.3	N/A	Gutter 2 Slope (%)	N/A
Yes	Refuge 2 X Slope (%)	1.2	N/A	Gutter 2 X Slope (%)	N/A
N/A	Painted X Walk2?	Yes	N/A	DWS 2 Provided?	N/A
N/A	X Walk 2 Direction	To NE	N/A	DWS 2 Contrast?	N/A
N/A	X Walk 2 Width (In)	110.5	N/A	DWS 2 Length (In)	N/A

N/A	Road 2 Slope (%)	1.9	N/A	DWS 2 Full Width?	N/A
N/A	Road 2 X Slope (%)	1.6	N/A	DWS 2 Offset (In)	N/A
N/A	Refuge 3 Length (in)	N/A	N/A	Gutter 3 Ponding?	N/A
N/A	Refuge 3 Width (in)	N/A	N/A	Gutter 3 Lip Ht (in)	N/A
N/A	Refuge 3 Slope (%)	N/A	N/A	Gutter 3 Slope (%)	N/A
N/A	Refuge 3 XSlope (%)	N/A	N/A	Gutter 3 XSlope (%)	N/A
N/A	Painted X Walk3?	N/A	N/A	DWS 3 Provided?	N/A
N/A	X Walk 3 Direction	N/A	N/A	DWS 3 Contrast?	N/A
N/A	X Walk 3 Width (in)	N/A	N/A	DWS 3 Length (in)	N/A
N/A	Road 3 Slope (%)	N/A	N/A	DWS 3 Full Width?	N/A
N/A	Road 3 XSlope (%)	N/A	N/A	DWS 3 Offset (in)	N/A
Yes	Any Obstructions?	N/A	N/A	Storm Grate/Utility Hazard?	N/A
N/A	Obstruction Type		N/A	Storm Grate/Utility Type	
		N/A			N/A
N/A	Surface Condition	Good

Remove & Replace Entire Refuge.
