Access Compliance Report

Public Rights-of-Way

(Island Curb Cuts)

Intersection ID: 3559	Main Street: PERIMETER_PY	Cross Street: W_W_T_HARRIS_BV	Location:	SW
ADA ID: F3B83AFA5E4C	Curb Cut Type: IslandRefuge3	Initial Pass/Fail: Fail	Overall Compliance: No	Severity Score: 47.5
Codes/Mitigation Info/Possible Solution		Field Measurements/Component Compliance

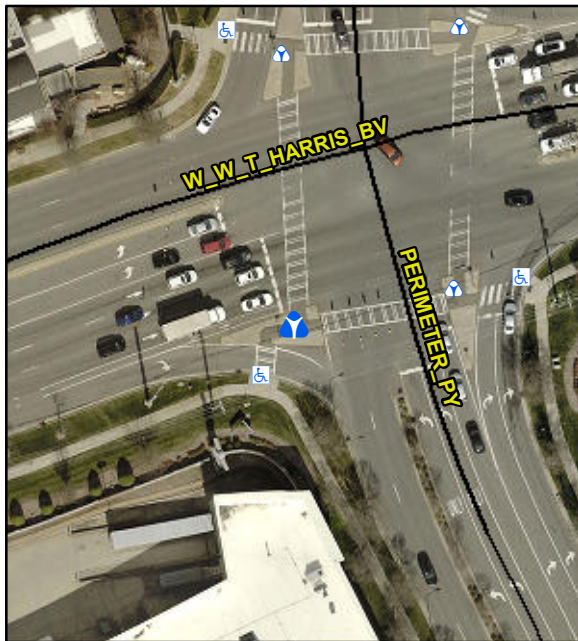
N/A	Road 2 Slope (%)	1.3	N/A	DWS 2 Full Width?	N/A
N/A	Road 2 X Slope (%)	3.5	N/A	DWS 2 Offset (In)	N/A
Yes	Refuge 3 Length (in)	42.0	N/A	Gutter 3 Ponding?	N/A
Yes	Refuge 3 Width (in)	72.0	N/A	Gutter 3 Lip Ht (in)	N/A
No	Refuge 3 Slope (%)	5.1	N/A	Gutter 3 Slope (%)	N/A
Yes	Refuge 3 XSlope (%)	0.5	N/A	Gutter 3 XSlope (%)	N/A
N/A	Painted X Walk3?	Yes	N/A	DWS 3 Provided?	N/A
N/A	X Walk 3 Direction	To SW	N/A	DWS 3 Contrast?	N/A
N/A	X Walk 3 Width (in)	109.0	N/A	DWS 3 Length (in)	N/A
N/A	Road 3 Slope (%)	1.2	N/A	DWS 3 Full Width?	N/A
N/A	Road 3 XSlope (%)	5.0	N/A	DWS 3 Offset (in)	N/A
Yes	Any Obstructions?	N/A	N/A	Storm Grate/Utility Hazard?	N/A
N/A	Obstruction Type		N/A	Storm Grate/Utility Type	
			N/A		N/A
N/A	Surface Condition	Good

Remove & Replace Entire Refuge.
