Access Compliance Report

Public Rights-of-Way

(Island Curb Cuts)

Intersection ID: 10035806	Main Street: REMOUNT_RD	Cross Street: N/A	Location: N
ADA ID: F482504EDBDB	Curb Cut Type: MedianRefuge2	Initial Pass/Fail: Fail	Overall Compliance: No
Codes/Mitigation Info/Possible Solution		Field Measurements/Component Compliance

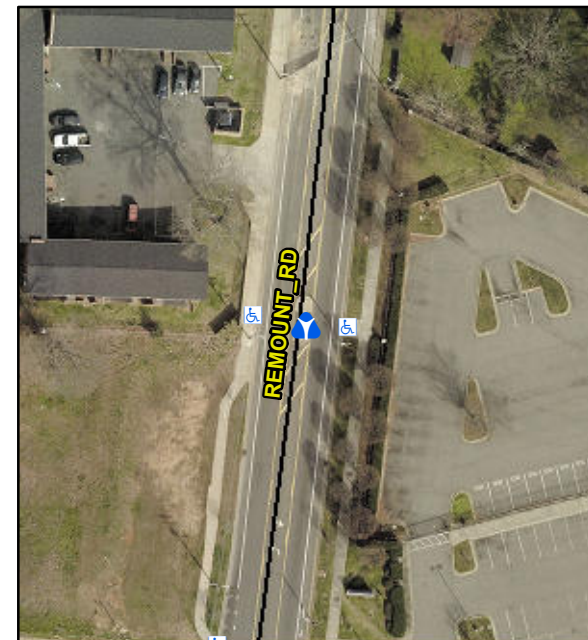
Compliance	Description	Data	Compliance	Description	Data
Yes	Refuge 1 Length (In)	53.0	N/A	Gutter 1 Ponding?	N/A
Yes	Refuge 1 Width (In)	96.0	N/A	Gutter 1 Lip Ht (In)	N/A
Yes	Refuge 1 Slope (%)	2.5	N/A	Gutter 1 Slope (%)	N/A
Yes	Refuge 1 X Slope (%)	3.1	N/A	Gutter 1 X Slope (%)	N/A
N/A	Painted X Walk1?	No	N/A	DWS 1 Provided?	N/A
N/A	X Walk 1 Direction	To E	N/A	DWS 1 Contrast?	N/A
N/A	X Walk 1 Width (In)	N/A	N/A	DWS 1 Length (In)	N/A
N/A	Road 1 Slope (%)	4.3	N/A	DWS 1 Full Width?	N/A
N/A	Road 1 X Slope (%)	6.0	N/A	DWS 1 Offset (In)	N/A
Yes	Refuge 2 Length (In)	55.0	N/A	Gutter 2 Ponding?	N/A
Yes	Refuge 2 Width (In)	96.0	N/A	Gutter 2 Lip Ht (In)	N/A
Yes	Refuge 2 Slope (%)	0.5	N/A	Gutter 2 Slope (%)	N/A
No	Refuge 2 X Slope (%)	5.7	N/A	Gutter 2 X Slope (%)	N/A
N/A	Painted X Walk2?	No	N/A	DWS 2 Provided?	N/A
N/A	X Walk 2 Direction	To W	N/A	DWS 2 Contrast?	N/A
N/A	X Walk 2 Width (In)	N/A	N/A	DWS 2 Length (In)	N/A

N/A	Road 2 Slope (%)	4.0	N/A	DWS 2 Full Width?	N/A
N/A	Road 2 X Slope (%)	1.3	N/A	DWS 2 Offset (In)	N/A
N/A	Refuge 3 Length (in)	N/A	N/A	Gutter 3 Ponding?	N/A
N/A	Refuge 3 Width (in)	N/A	N/A	Gutter 3 Lip Ht (in)	N/A
N/A	Refuge 3 Slope (%)	N/A	N/A	Gutter 3 Slope (%)	N/A
N/A	Refuge 3 XSlope (%)	N/A	N/A	Gutter 3 XSlope (%)	N/A
N/A	Painted X Walk3?	N/A	N/A	DWS 3 Provided?	N/A
N/A	X Walk 3 Direction	N/A	N/A	DWS 3 Contrast?	N/A
N/A	X Walk 3 Width (in)	N/A	N/A	DWS 3 Length (in)	N/A
N/A	Road 3 Slope (%)	N/A	N/A	DWS 3 Full Width?	N/A
N/A	Road 3 XSlope (%)	N/A	N/A	DWS 3 Offset (in)	N/A
Yes	Any Obstructions?	N/A	N/A	Storm Grate/Utility Hazard?	N/A
N/A	Obstruction Type		N/A	Storm Grate/Utility Type	
			N/A		N/A
N/A	Surface Condition	Good

Remove & Replace Entire Refuge.
