Access Compliance Report

Public Rights-of-Way

(Island Curb Cuts)

Intersection ID: N/A	Main Street: UNIVERSITY CITY BV	Cross Street: N/A	Location: E
ADA ID: F50EAACDC81	Curb Cut Type: MedianRefuge2	Initial Pass/Fail: N/A	Overall Compliance: Yes
		Severity Score: 0

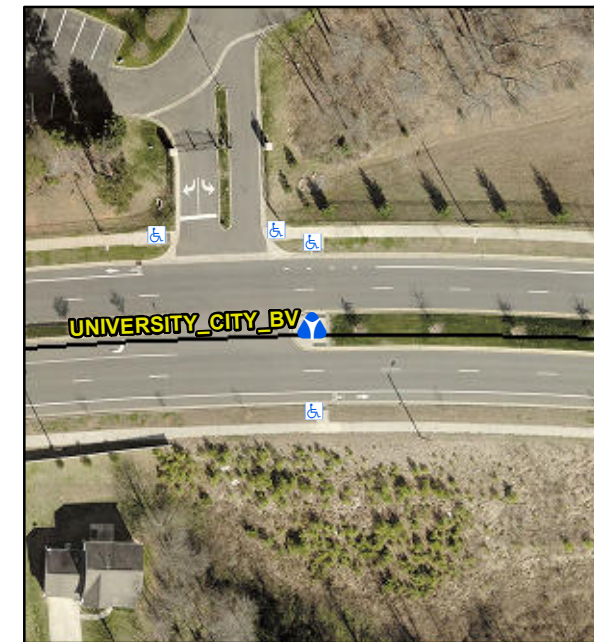
Compliance	Description	Data	Compliance	Description	Data
Yes	Refuge 1 Length (In)	105.0	N/A	Gutter 1 Ponding?	N/A
Yes	Refuge 1 Width (In)	96.0	N/A	Gutter 1 Lip Ht (In)	N/A
Yes	Refuge 1 Slope (%)	1.3	N/A	Gutter 1 Slope (%)	N/A
Yes	Refuge 1 X Slope (%)	5.0	N/A	Gutter 1 X Slope (%)	N/A
N/A	Painted X Walk1?	No	N/A	DWS 1 Provided?	N/A
N/A	X Walk 1 Direction	To N	N/A	DWS 1 Contrast?	N/A
N/A	X Walk 1 Width (In)	N/A	N/A	DWS 1 Length (In)	N/A
N/A	Road 1 Slope (%)	4.5	N/A	DWS 1 Full Width?	N/A
N/A	Road 1 X Slope (%)	3.6	N/A	DWS 1 Offset (In)	N/A
Yes	Refuge 2 Length (In)	99.0	N/A	Gutter 2 Ponding?	N/A
Yes	Refuge 2 Width (In)	96.0	N/A	Gutter 2 Lip Ht (In)	N/A
Yes	Refuge 2 Slope (%)	0.0	N/A	Gutter 2 Slope (%)	N/A
Yes	Refuge 2 X Slope (%)	4.2	N/A	Gutter 2 X Slope (%)	N/A
N/A	Painted X Walk2?	No	N/A	DWS 2 Provided?	N/A
N/A	X Walk 2 Direction	To S	N/A	DWS 2 Contrast?	N/A
N/A	X Walk 2 Width (In)	N/A	N/A	DWS 2 Length (In)	N/A

N/A	Road 2 Slope (%)	4.7	N/A	DWS 2 Full Width?	N/A
N/A	Road 2 X Slope (%)	0.6	N/A	DWS 2 Offset (In)	N/A
N/A	Refuge 3 Length (in)	N/A	N/A	Gutter 3 Ponding?	N/A
N/A	Refuge 3 Width (in)	N/A	N/A	Gutter 3 Lip Ht (in)	N/A
N/A	Refuge 3 Slope (%)	N/A	N/A	Gutter 3 Slope (%)	N/A
N/A	Refuge 3 XSlope (%)	N/A	N/A	Gutter 3 XSlope (%)	N/A
N/A	Painted X Walk3?	N/A	N/A	DWS 3 Provided?	N/A
N/A	X Walk 3 Direction	N/A	N/A	DWS 3 Contrast?	N/A
N/A	X Walk 3 Width (in)	N/A	N/A	DWS 3 Length (in)	N/A
N/A	Road 3 Slope (%)	N/A	N/A	DWS 3 Full Width?	N/A
N/A	Road 3 XSlope (%)	N/A	N/A	DWS 3 Offset (in)	N/A
Yes	Any Obstructions?	N/A	N/A	Storm Grate/Utility Hazard?	N/A
N/A	Obstruction Type		N/A	Storm Grate/Utility Type	
		N/A			N/A
N/A	Surface Condition	Good

N/A
