Access Compliance Report

Public Rights-of-Way

(Island Curb Cuts)

Intersection ID: 23977	Main Street: REA_RD	Cross Street: WINDYRUSH_RD	Location: E
ADA ID: F5919E304EE2	Curb Cut Type: MedianRefuge2	Initial Pass/Fail: Fail	Overall Compliance: No
Severity Score: 0			
Codes/Mitigation Info/Possible Solution		Field Measurements/Component Compliance

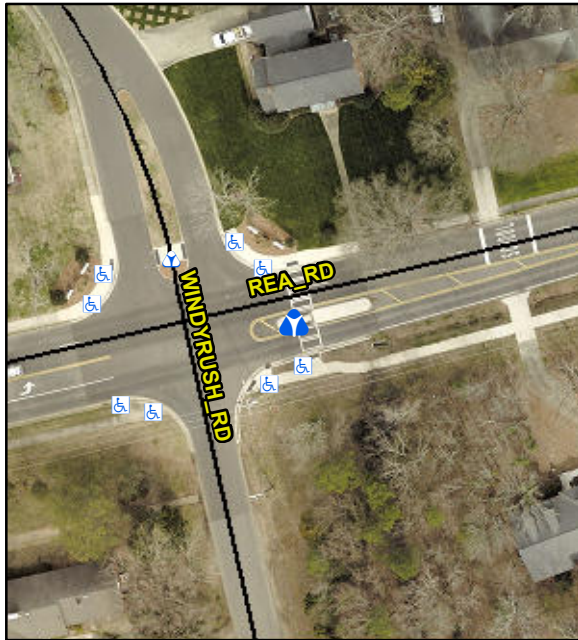
Compliance	Description	Data	Compliance	Description	Data
Yes	Refuge 1 Length (In)	44.0	N/A	Gutter 1 Ponding?	N/A
Yes	Refuge 1 Width (In)	96.0	N/A	Gutter 1 Lip Ht (In)	N/A
Yes	Refuge 1 Slope (%)	1.7	N/A	Gutter 1 Slope (%)	N/A
Yes	Refuge 1 X Slope (%)	4.6	N/A	Gutter 1 X Slope (%)	N/A
N/A	Painted X Walk1?	Yes	N/A	DWS 1 Provided?	N/A
N/A	X Walk 1 Direction	To NW	N/A	DWS 1 Contrast?	N/A
N/A	X Walk 1 Width (In)	111.0	N/A	DWS 1 Length (In)	N/A
N/A	Road 1 Slope (%)	3.8	N/A	DWS 1 Full Width?	N/A
N/A	Road 1 X Slope (%)	1.1	N/A	DWS 1 Offset (In)	N/A
Yes	Refuge 2 Length (In)	44.0	N/A	Gutter 2 Ponding?	N/A
Yes	Refuge 2 Width (In)	96.0	N/A	Gutter 2 Lip Ht (In)	N/A
Yes	Refuge 2 Slope (%)	1.2	N/A	Gutter 2 Slope (%)	N/A
Yes	Refuge 2 X Slope (%)	1.8	N/A	Gutter 2 X Slope (%)	N/A
N/A	Painted X Walk2?	Yes	N/A	DWS 2 Provided?	N/A
N/A	X Walk 2 Direction	To SE	N/A	DWS 2 Contrast?	N/A
N/A	X Walk 2 Width (In)	113.0	N/A	DWS 2 Length (In)	N/A

Remove & Replace Entire Refuge.
