Access Compliance Report

Public Rights-of-Way

(Island Curb Cuts)

Intersection ID: 10040992	Main Street: WALTON_RD	Cross Street: N/A	Location: E
ADA ID: F6AF99A25506	Curb Cut Type: MedianRefuge2	Initial Pass/Fail: Fail	Overall Compliance: No
Codes/Mitigation Info/Possible Solution		Field Measurements/Component Compliance	
Severity Score: 25

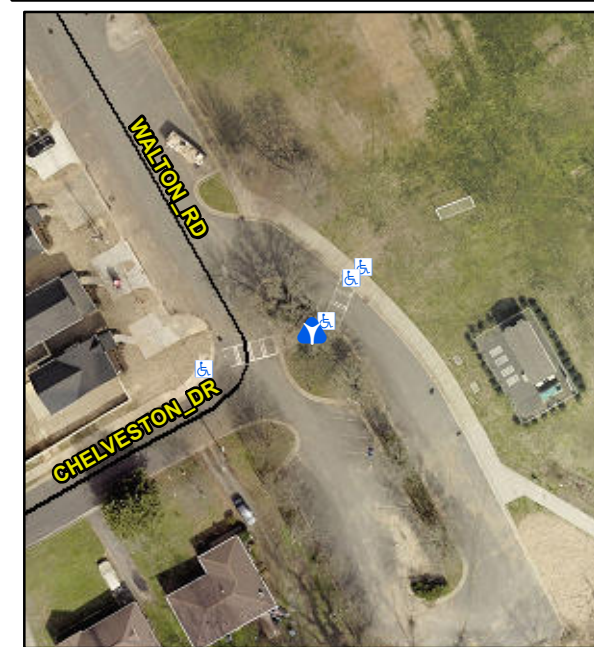
Compliance	Description	Data	Compliance	Description	Data
Yes	Refuge 1 Length (In)	149.0	N/A	Gutter 1 Ponding?	N/A
Yes	Refuge 1 Width (In)	71.0	N/A	Gutter 1 Lip Ht (In)	N/A
Yes	Refuge 1 Slope (%)	1.4	N/A	Gutter 1 Slope (%)	N/A
Yes	Refuge 1 X Slope (%)	3.3	N/A	Gutter 1 X Slope (%)	N/A
N/A	Painted X Walk1?	Yes	N/A	DWS 1 Provided?	N/A
N/A	X Walk 1 Direction	To W	N/A	DWS 1 Contrast?	N/A
N/A	X Walk 1 Width (In)	104.0	N/A	DWS 1 Length (In)	N/A
N/A	Road 1 Slope (%)	3.2	N/A	DWS 1 Full Width?	N/A
N/A	Road 1 X Slope (%)	5.9	N/A	DWS 1 Offset (In)	N/A
Yes	Refuge 2 Length (In)	149.0	N/A	Gutter 2 Ponding?	N/A
Yes	Refuge 2 Width (In)	71.0	N/A	Gutter 2 Lip Ht (In)	N/A
No	Refuge 2 Slope (%)	6.4	N/A	Gutter 2 Slope (%)	N/A
No	Refuge 2 X Slope (%)	5.1	N/A	Gutter 2 X Slope (%)	N/A
N/A	Painted X Walk2?	Yes	N/A	DWS 2 Provided?	N/A
N/A	X Walk 2 Direction	To NE	N/A	DWS 2 Contrast?	N/A
N/A	X Walk 2 Width (In)	98.0	N/A	DWS 2 Length (In)	N/A

N/A	Road 2 Slope (%)	6.1	N/A	DWS 2 Full Width?	N/A
N/A	Road 2 X Slope (%)	2.0	N/A	DWS 2 Offset (In)	N/A
N/A	Refuge 3 Length (in)	N/A	N/A	Gutter 3 Ponding?	N/A
N/A	Refuge 3 Width (in)	N/A	N/A	Gutter 3 Lip Ht (in)	N/A
N/A	Refuge 3 Slope (%)	N/A	N/A	Gutter 3 Slope (%)	N/A
N/A	Refuge 3 XSlope (%)	N/A	N/A	Gutter 3 XSlope (%)	N/A
N/A	Painted X Walk3?	N/A	N/A	DWS 3 Provided?	N/A
N/A	X Walk 3 Direction	N/A	N/A	DWS 3 Contrast?	N/A
N/A	X Walk 3 Width (in)	N/A	N/A	DWS 3 Length (in)	N/A
N/A	Road 3 Slope (%)	N/A	N/A	DWS 3 Full Width?	N/A
N/A	Road 3 XSlope (%)	N/A	N/A	DWS 3 Offset (in)	N/A
Yes	Any Obstructions?	N/A	N/A	Storm Grate/Utility Hazard?	N/A
N/A	Obstruction Type		N/A	Storm Grate/Utility Type	
		N/A			N/A
N/A	Surface Condition	Good

Possible Solutions:

Remove & Replace Entire Refuge.
