Access Compliance Report

Public Rights-of-Way

(Island Curb Cuts)

Intersection ID: 53972	Main Street: SHOPTON_RD_WEST	Cross Street: CADEN_RD	Location: SE
ADA ID: F771BD51F6A8	Curb Cut Type: MedianRefuge2	Initial Pass/Fail: Fail	Overall Compliance: No
Severity Score: 0			
Codes/Mitigation Info/Possible Solution		Field Measurements/Component Compliance

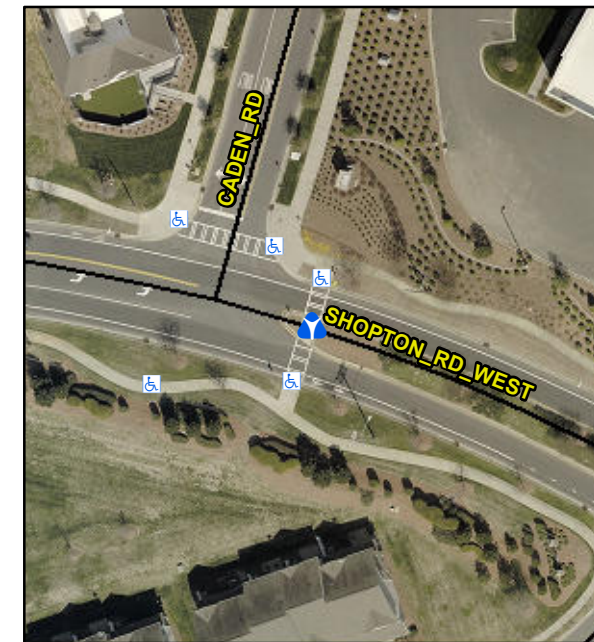
Compliance	Description	Data	Compliance	Description	Data
Yes	Refuge 1 Length (In)	63.5	N/A	Gutter 1 Ponding?	N/A
Yes	Refuge 1 Width (In)	97.5	N/A	Gutter 1 Lip Ht (In)	N/A
Yes	Refuge 1 Slope (%)	0.6	N/A	Gutter 1 Slope (%)	N/A
Yes	Refuge 1 X Slope (%)	3.2	N/A	Gutter 1 X Slope (%)	N/A
N/A	Painted X Walk1?	Yes	N/A	DWS 1 Provided?	N/A
N/A	X Walk 1 Direction	To NE	N/A	DWS 1 Contrast?	N/A
N/A	X Walk 1 Width (In)	96.0	N/A	DWS 1 Length (In)	N/A
N/A	Road 1 Slope (%)	1.0	N/A	DWS 1 Full Width?	N/A
N/A	Road 1 X Slope (%)	4.4	N/A	DWS 1 Offset (In)	N/A
Yes	Refuge 2 Length (In)	63.5	N/A	Gutter 2 Ponding?	N/A
Yes	Refuge 2 Width (In)	97.5	N/A	Gutter 2 Lip Ht (In)	N/A
Yes	Refuge 2 Slope (%)	1.7	N/A	Gutter 2 Slope (%)	N/A
Yes	Refuge 2 X Slope (%)	2.3	N/A	Gutter 2 X Slope (%)	N/A
N/A	Painted X Walk2?	Yes	N/A	DWS 2 Provided?	N/A
N/A	X Walk 2 Direction	To SW	N/A	DWS 2 Contrast?	N/A
N/A	X Walk 2 Width (In)	95.0	N/A	DWS 2 Length (In)	N/A

N/A	Road 2 Slope (%)	1.3	N/A	DWS 2 Full Width?	N/A
N/A	Road 2 X Slope (%)	2.6	N/A	DWS 2 Offset (In)	N/A
N/A	Refuge 3 Length (in)	N/A	N/A	Gutter 3 Ponding?	N/A
N/A	Refuge 3 Width (in)	N/A	N/A	Gutter 3 Lip Ht (in)	N/A
N/A	Refuge 3 Slope (%)	N/A	N/A	Gutter 3 Slope (%)	N/A
N/A	Refuge 3 XSlope (%)	N/A	N/A	Gutter 3 XSlope (%)	N/A
N/A	Painted X Walk3?	N/A	N/A	DWS 3 Provided?	N/A
N/A	X Walk 3 Direction	N/A	N/A	DWS 3 Contrast?	N/A
N/A	X Walk 3 Width (in)	N/A	N/A	DWS 3 Length (in)	N/A
N/A	Road 3 Slope (%)	N/A	N/A	DWS 3 Full Width?	N/A
N/A	Road 3 XSlope (%)	N/A	N/A	DWS 3 Offset (in)	N/A
Yes	Any Obstructions?	N/A	N/A	Storm Grate/Utility Hazard?	N/A
N/A	Obstruction Type		N/A	Storm Grate/Utility Type	
		N/A			N/A
N/A	Surface Condition	Good

Possible Solutions:

Remove & Replace Entire Refuge.

Total Cost: \$ 3000.00
