# Access Compliance Report

## Public Rights-of-Way

### (Island Curb Cuts)

Intersection ID: 18818	Main Street: BEAM_RD	Cross Street: SHOPTON_RD	Location: W
ADA ID: F7C944A15934	Curb Cut Type: MedianRefuge2	Initial Pass/Fail: Fail	Overall Compliance: No
Severity Score: 1.25			
Codes/Mitigation Info/Possible Solution		Field Measurements/Component Compliance

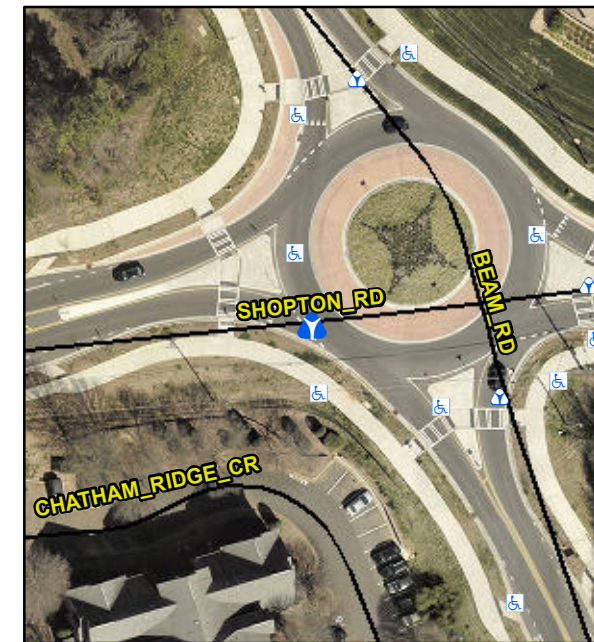
Compliance	Description	Data	Compliance	Description	Data
Yes	Refuge 1 Length (In)	105	N/A	Gutter 1 Ponding?	N/A
Yes	Refuge 1 Width (In)	119	N/A	Gutter 1 Lip Ht (In)	N/A
Yes	Refuge 1 Slope (%)	0.3	N/A	Gutter 1 Slope (%)	N/A
Yes	Refuge 1 X Slope (%)	3.7	N/A	Gutter 1 X Slope (%)	N/A
N/A	Painted X Walk1?	Yes	N/A	DWS 1 Provided?	N/A
N/A	X Walk 1 Direction	To N	N/A	DWS 1 Contrast?	N/A
N/A	X Walk 1 Width (In)	112	N/A	DWS 1 Length (In)	N/A
N/A	Road 1 Slope (%)	1.9	N/A	DWS 1 Full Width?	N/A
N/A	Road 1 X Slope (%)	1.2	N/A	DWS 1 Offset (In)	N/A
Yes	Refuge 2 Length (In)	105	N/A	Gutter 2 Ponding?	N/A
Yes	Refuge 2 Width (In)	119	N/A	Gutter 2 Lip Ht (In)	N/A
Yes	Refuge 2 Slope (%)	3.9	N/A	Gutter 2 Slope (%)	N/A
Yes	Refuge 2 X Slope (%)	0.8	N/A	Gutter 2 X Slope (%)	N/A
N/A	Painted X Walk2?	Yes	N/A	DWS 2 Provided?	N/A
N/A	X Walk 2 Direction	To S	N/A	DWS 2 Contrast?	N/A
N/A	X Walk 2 Width (In)	112	N/A	DWS 2 Length (In)	N/A

**Remove & Replace Entire Refuge.**
