Access Compliance Report

Public Rights-of-Way

(Island Curb Cuts)

Intersection ID: 51704	Main Street: IKEA_BV	Cross Street: N/A	Location: S
ADA ID: F88FB8587A43	Curb Cut Type: MedianRefuge2	Initial Pass/Fail: Pass	Overall Compliance: No
			Severity Score: 15

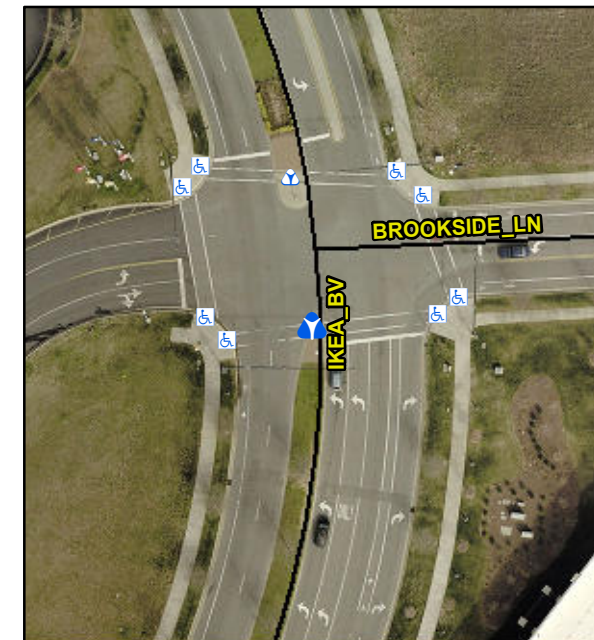
Compliance	Description	Data	Compliance	Description	Data
Yes	Refuge 1 Length (In)	52.5	Yes	Gutter 1 Ponding?	No
Yes	Refuge 1 Width (In)	70.0	No	Gutter 1 Lip Ht (In)	0.25
Yes	Refuge 1 Slope (%)	1.2	Yes	Gutter 1 Slope (%)	0.9
Yes	Refuge 1 X Slope (%)	0.5	Yes	Gutter 1 X Slope (%)	0.5
N/A	Painted X Walk1?	Yes	No	DWS 1 Provided?	No
N/A	X Walk 1 Direction	To E	N/A	DWS 1 Contrast?	No
N/A	X Walk 1 Width (In)	69.0	N/A	DWS 1 Length (In)	N/A
N/A	Road 1 Slope (%)	0.8	N/A	DWS 1 Full Width?	No
N/A	Road 1 X Slope (%)	4.0	N/A	DWS 1 Offset (In)	N/A
Yes	Refuge 2 Length (In)	52.5	Yes	Gutter 2 Ponding?	No
Yes	Refuge 2 Width (In)	70.0	No	Gutter 2 Lip Ht (In)	0.25
Yes	Refuge 2 Slope (%)	0.3	Yes	Gutter 2 Slope (%)	0.8
Yes	Refuge 2 X Slope (%)	0.1	Yes	Gutter 2 X Slope (%)	0.2
N/A	Painted X Walk2?	Yes	No	DWS 2 Provided?	No
N/A	X Walk 2 Direction	To W	N/A	DWS 2 Contrast?	No
N/A	X Walk 2 Width (In)	70.0	N/A	DWS 2 Length (In)	N/A
N/A	Road 2 Slope (%)	2.3	N/A	DWS 2 Full Width?	No

N/A	Road 2 X Slope (%)	1.8	N/A	DWS 2 Offset (In)	N/A
N/A	Refuge 3 Length (in)	N/A	N/A	Gutter 3 Ponding?	No
N/A	Refuge 3 Width (in)	N/A	N/A	Gutter 3 Lip Ht (in)	N/A
N/A	Refuge 3 Slope (%)	N/A	N/A	Gutter 3 Slope (%)	N/A
N/A	Refuge 3 XSlope (%)	N/A	N/A	Gutter 3 XSlope (%)	N/A
N/A	Painted X Walk3?	No	N/A	DWS 3 Provided?	N/A
N/A	X Walk 3 Direction	N/A	N/A	DWS 3 Contrast?	N/A
N/A	X Walk 3 Width (in)	N/A	N/A	DWS 3 Length (in)	N/A
N/A	Road 3 Slope (%)	N/A	N/A	DWS 3 Full Width?	N/A
N/A	Road 3 XSlope (%)	N/A	N/A	DWS 3 Offset (in)	N/A
Yes	Any Obstructions?	No	N/A	Storm Grate/Utility Hazard?	No
N/A	Obstruction Type		N/A	Storm Grate/Utility Type	
		N/A			N/A
N/A	Surface Condition	Good

**Install Detectable Warning System.
Grind Gutter Lip.**
