# Access Compliance Report

## Public Rights-of-Way

### (Island Curb Cuts)

Intersection ID: 53534	Main Street: N_JOSH_BIRMINGHAM_PY	Cross Street: WILKINSON_BV	Location: SW
ADA ID: F9057DC45DBE	Curb Cut Type: IslandRefuge3	Initial Pass/Fail: Fail	Overall Compliance: No
Codes/Mitigation Info/Possible Solution		Field Measurements/Component Compliance	
Severity Score: 35

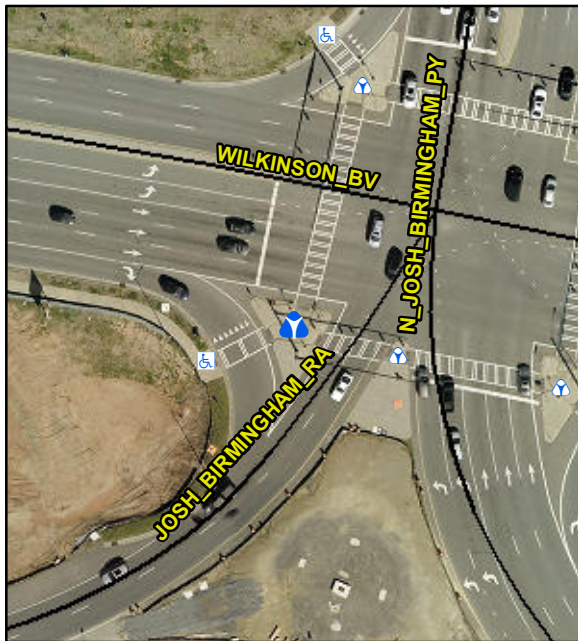
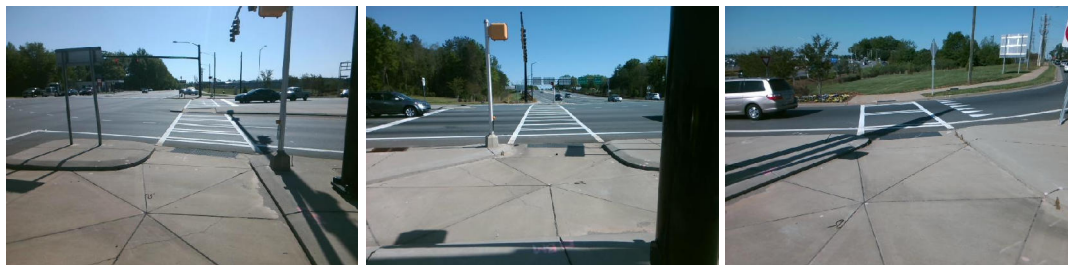
Compliance	Description	Data	Compliance	Description	Data
Yes	Refuge 1 Length (In)	77.0	N/A	Gutter 1 Ponding?	N/A
Yes	Refuge 1 Width (In)	96.0	N/A	Gutter 1 Lip Ht (In)	N/A
Yes	Refuge 1 Slope (%)	0.2	N/A	Gutter 1 Slope (%)	N/A
Yes	Refuge 1 X Slope (%)	3.2	N/A	Gutter 1 X Slope (%)	N/A
N/A	Painted X Walk1?	Yes	N/A	DWS 1 Provided?	N/A
N/A	X Walk 1 Direction	To E	N/A	DWS 1 Contrast?	N/A
N/A	X Walk 1 Width (In)	110.0	N/A	DWS 1 Length (In)	N/A
N/A	Road 1 Slope (%)	2.2	N/A	DWS 1 Full Width?	N/A
N/A	Road 1 X Slope (%)	0.4	N/A	DWS 1 Offset (In)	N/A
Yes	Refuge 2 Length (In)	62.0	N/A	Gutter 2 Ponding?	N/A
Yes	Refuge 2 Width (In)	99.0	N/A	Gutter 2 Lip Ht (In)	N/A
Yes	Refuge 2 Slope (%)	1.6	N/A	Gutter 2 Slope (%)	N/A
Yes	Refuge 2 X Slope (%)	3.5	N/A	Gutter 2 X Slope (%)	N/A
N/A	Painted X Walk2?	Yes	N/A	DWS 2 Provided?	N/A
N/A	X Walk 2 Direction	To SW	N/A	DWS 2 Contrast?	N/A
N/A	X Walk 2 Width (In)	107.0	N/A	DWS 2 Length (In)	N/A

N/A	Road 2 Slope (%)	2.1	N/A	DWS 2 Full Width?	N/A
N/A	Road 2 X Slope (%)	3.6	N/A	DWS 2 Offset (In)	N/A
Yes	Refuge 3 Length (in)	69.0	N/A	Gutter 3 Ponding?	N/A
Yes	Refuge 3 Width (in)	111.0	N/A	Gutter 3 Lip Ht (in)	N/A
Yes	Refuge 3 Slope (%)	1.9	N/A	Gutter 3 Slope (%)	N/A
Yes	Refuge 3 XSlope (%)	0.6	N/A	Gutter 3 XSlope (%)	N/A
N/A	Painted X Walk3?	Yes	N/A	DWS 3 Provided?	N/A
N/A	X Walk 3 Direction	To N	N/A	DWS 3 Contrast?	N/A
N/A	X Walk 3 Width (in)	114.0	N/A	DWS 3 Length (in)	N/A
N/A	Road 3 Slope (%)	0.9	N/A	DWS 3 Full Width?	N/A
N/A	Road 3 XSlope (%)	1.2	N/A	DWS 3 Offset (in)	N/A
Yes	Any Obstructions?	N/A	N/A	Storm Grate/Utility Hazard?	N/A
N/A	Obstruction Type		N/A	Storm Grate/Utility Type	
			N/A		N/A
N/A	Surface Condition	Good

**Remove & Replace Entire Refuge.**

Total Cost: \$ 3000.00
