Access Compliance Report

Public Rights-of-Way

(Island Curb Cuts)

Intersection ID: 15800	Main Street: PROVIDENCE_RD	Cross Street: QUEENS_RD	Location:	SW
ADA ID: F9455288E701	Curb Cut Type: IslandRefuge3	Initial Pass/Fail: Fail	Overall Compliance: No	Severity Score: 47.5
Codes/Mitigation Info/Possible Solution		Field Measurements/Component Compliance

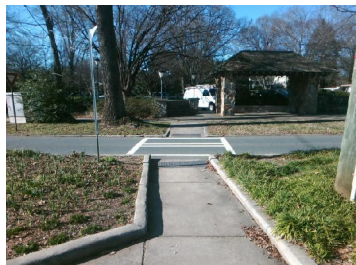
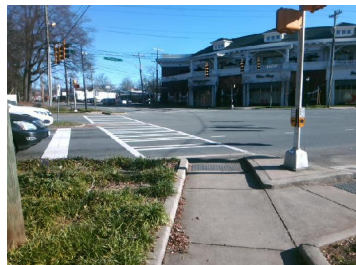
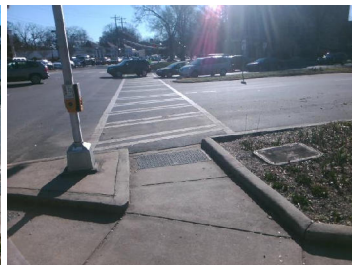
Compliance	Description	Data	Compliance	Description	Data
Yes	Refuge 1 Length (In)	146.0	N/A	Gutter 1 Ponding?	N/A
No	Refuge 1 Width (In)	56.0	N/A	Gutter 1 Lip Ht (In)	N/A
No	Refuge 1 Slope (%)	5.1	N/A	Gutter 1 Slope (%)	N/A
Yes	Refuge 1 X Slope (%)	2.8	N/A	Gutter 1 X Slope (%)	N/A
N/A	Painted X Walk1?	Yes	N/A	DWS 1 Provided?	N/A
N/A	X Walk 1 Direction	To SW	N/A	DWS 1 Contrast?	N/A
N/A	X Walk 1 Width (In)	110.0	N/A	DWS 1 Length (In)	N/A
N/A	Road 1 Slope (%)	2.3	N/A	DWS 1 Full Width?	N/A
N/A	Road 1 X Slope (%)	5.2	N/A	DWS 1 Offset (In)	N/A
Yes	Refuge 2 Length (In)	93.0	N/A	Gutter 2 Ponding?	N/A
No	Refuge 2 Width (In)	55.0	N/A	Gutter 2 Lip Ht (In)	N/A
Yes	Refuge 2 Slope (%)	1.3	N/A	Gutter 2 Slope (%)	N/A
Yes	Refuge 2 X Slope (%)	1.5	N/A	Gutter 2 X Slope (%)	N/A
N/A	Painted X Walk2?	Yes	N/A	DWS 2 Provided?	N/A
N/A	X Walk 2 Direction	To NE	N/A	DWS 2 Contrast?	N/A
N/A	X Walk 2 Width (In)	112.0	N/A	DWS 2 Length (In)	N/A

N/A	Road 2 Slope (%)	2.1	N/A	DWS 2 Full Width?	N/A
N/A	Road 2 X Slope (%)	0.8	N/A	DWS 2 Offset (In)	N/A
Yes	Refuge 3 Length (in)	77.0	N/A	Gutter 3 Ponding?	N/A
No	Refuge 3 Width (in)	57.0	N/A	Gutter 3 Lip Ht (in)	N/A
Yes	Refuge 3 Slope (%)	2.1	N/A	Gutter 3 Slope (%)	N/A
Yes	Refuge 3 XSlope (%)	2.6	N/A	Gutter 3 XSlope (%)	N/A
N/A	Painted X Walk3?	Yes	N/A	DWS 3 Provided?	N/A
N/A	X Walk 3 Direction	To SE	N/A	DWS 3 Contrast?	N/A
N/A	X Walk 3 Width (in)	114.0	N/A	DWS 3 Length (in)	N/A
N/A	Road 3 Slope (%)	1.0	N/A	DWS 3 Full Width?	N/A
N/A	Road 3 XSlope (%)	0.8	N/A	DWS 3 Offset (in)	N/A
Yes	Any Obstructions?	N/A	N/A	Storm Grate/Utility Hazard?	N/A
N/A	Obstruction Type		N/A	Storm Grate/Utility Type	
			N/A		N/A
N/A	Surface Condition	Good

Remove & Replace Entire Refuge.
