# Access Compliance Report

## Public Rights-of-Way

### (Island Curb Cuts)

Intersection ID: 19817	Main Street: MONROE_RD	Cross Street: TIMBER_SPRINGS_DR	Location: SW
ADA ID: FA9761A9E819	Curb Cut Type: IslandRefuge3	Initial Pass/Fail: Pass	Overall Compliance: No
Codes/Mitigation Info/Possible Solution		Field Measurements/Component Compliance	
Severity Score: 10

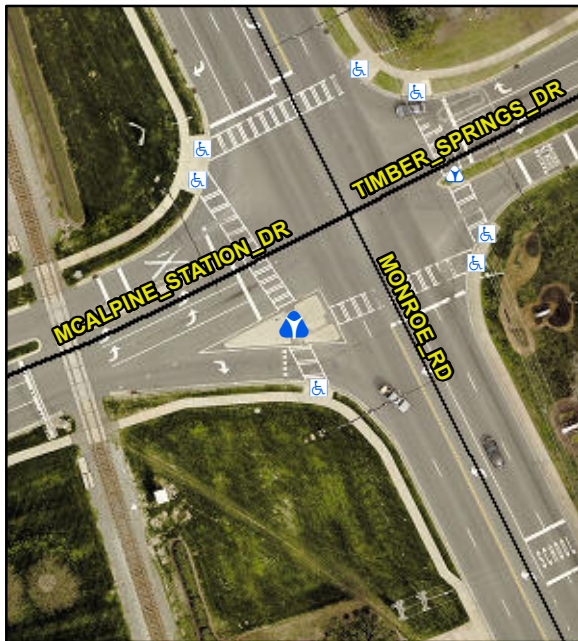
N/A	Road 2 Slope (%)	1.1	No	DWS 2 Full Width?	No
N/A	Road 2 X Slope (%)	2.9	Yes	DWS 2 Offset (In)	0.0
Yes	Refuge 3 Length (in)	133.0	Yes	Gutter 3 Ponding?	No
Yes	Refuge 3 Width (in)	70.0	Yes	Gutter 3 Lip Ht (in)	0.0
Yes	Refuge 3 Slope (%)	0.5	Yes	Gutter 3 Slope (%)	1.0
Yes	Refuge 3 XSlope (%)	0.9	Yes	Gutter 3 XSlope (%)	0.0
N/A	Painted X Walk3?	Yes	Yes	DWS 3 Provided?	Yes
N/A	X Walk 3 Direction	To NW	Yes	DWS 3 Contrast?	Yes
N/A	X Walk 3 Width (in)	112.0	Yes	DWS 3 Length (in)	24.0
N/A	Road 3 Slope (%)	0.3	No	DWS 3 Full Width?	No
N/A	Road 3 XSlope (%)	1.6	Yes	DWS 3 Offset (in)	0.0
Yes	Any Obstructions?	N/A	N/A	Storm Grate/Utility Hazard?	No
N/A	Obstruction Type	N/A	N/A	Storm Grate/Utility Type	N/A
N/A	Surface Condition	Good

**Remove & Replace Detectable Warning System.**
