# Access Compliance Report

## Public Rights-of-Way

### (Island Curb Cuts)

Intersection ID: 12158	Main Street: W_MOREHEAD_ST	Cross Street: SUTTLE_AVE	Location: S
ADA ID: FC7D4DDCA366	Curb Cut Type: MedianRefuge2	Initial Pass/Fail: Fail	Overall Compliance: No
Codes/Mitigation Info/Possible Solution		Field Measurements/Component Compliance

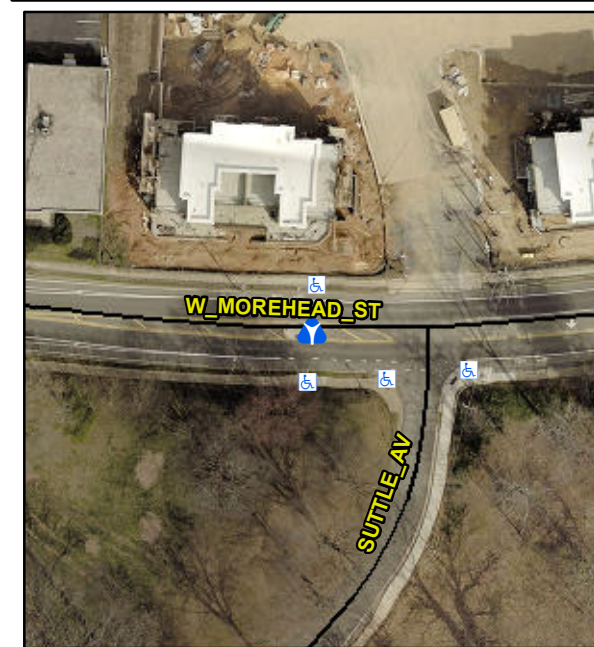
Compliance	Description	Data	Compliance	Description	Data
Yes	Refuge 1 Length (In)	49.0	N/A	Gutter 1 Ponding?	N/A
Yes	Refuge 1 Width (In)	98.0	N/A	Gutter 1 Lip Ht (In)	N/A
Yes	Refuge 1 Slope (%)	1.9	N/A	Gutter 1 Slope (%)	N/A
No	Refuge 1 X Slope (%)	6.9	N/A	Gutter 1 X Slope (%)	N/A
N/A	Painted X Walk1?	No	N/A	DWS 1 Provided?	N/A
N/A	X Walk 1 Direction	To S	N/A	DWS 1 Contrast?	N/A
N/A	X Walk 1 Width (In)	N/A	N/A	DWS 1 Length (In)	N/A
N/A	Road 1 Slope (%)	8.2	N/A	DWS 1 Full Width?	N/A
N/A	Road 1 X Slope (%)	4.2	N/A	DWS 1 Offset (In)	N/A
Yes	Refuge 2 Length (In)	49.0	N/A	Gutter 2 Ponding?	N/A
Yes	Refuge 2 Width (In)	98.0	N/A	Gutter 2 Lip Ht (In)	N/A
Yes	Refuge 2 Slope (%)	2.2	N/A	Gutter 2 Slope (%)	N/A
No	Refuge 2 X Slope (%)	7.5	N/A	Gutter 2 X Slope (%)	N/A
N/A	Painted X Walk2?	No	N/A	DWS 2 Provided?	N/A
N/A	X Walk 2 Direction	To N	N/A	DWS 2 Contrast?	N/A
N/A	X Walk 2 Width (In)	N/A	N/A	DWS 2 Length (In)	N/A

**Remove & Replace Entire Refuge.**
