Access Compliance Report

Public Rights-of-Way

(Island Curb Cuts)

| Intersection ID: 44850 | Main Street: STEELE_CREEK_RD | Cross Street: SHOPTON_RD_WEST | Location: W |

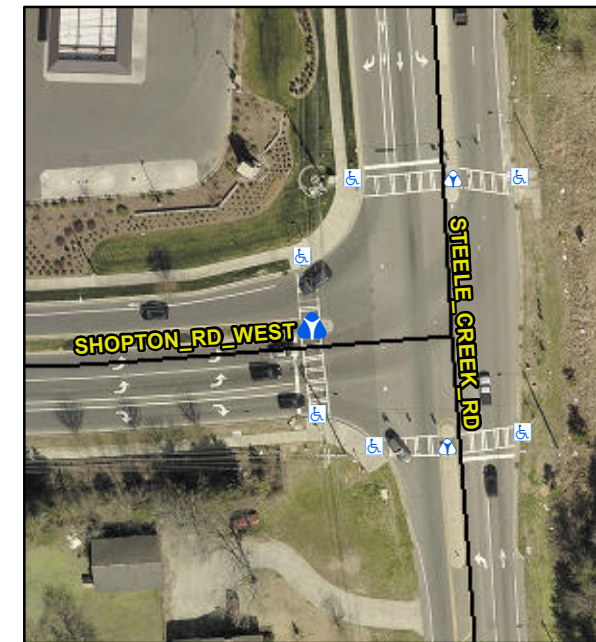
| ADA ID: FC7E6D5C3106 | Curb Cut Type: MedianRefuge2 | Initial Pass/Fail: Fail | Overall Compliance: No |
| Severity Score: 1.25 | | | |

Remove & Replace Entire Refuge.
